Great Lakes

Home Inspectors

August 28th 2018, 1:00 pm

BUILDING ADDRESS: 1234 Example
CITY: Sampleville
STATE: Michigan
ZIP CODE: 12345
INSPECTION DESCRIPTION: Whole home and attached garage.

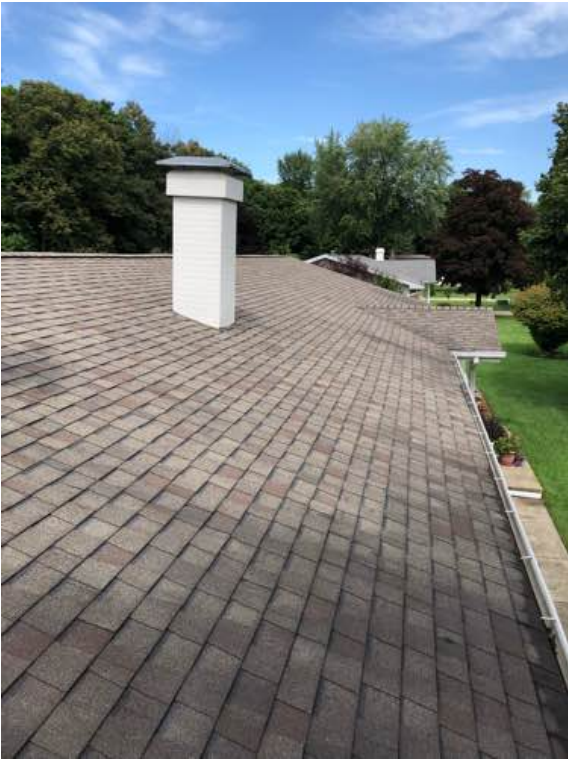
Roof was walked during inspection.

General photo of roof below.

4/12 pitch.

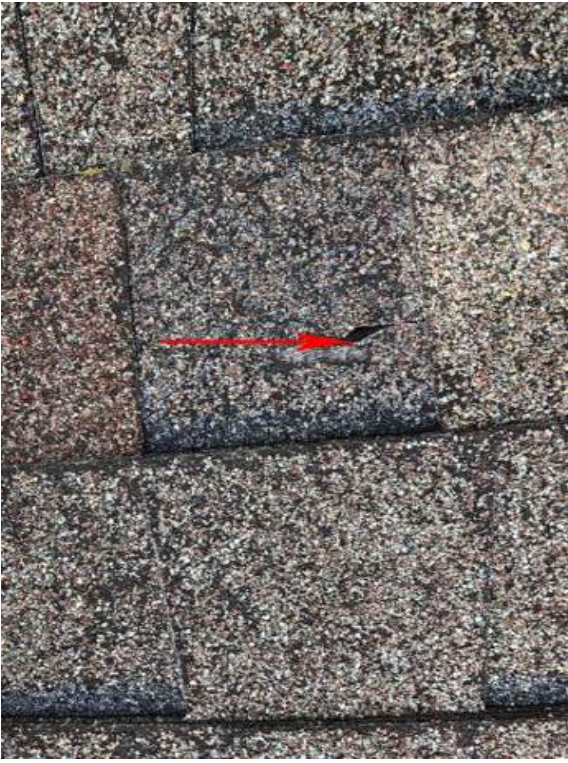
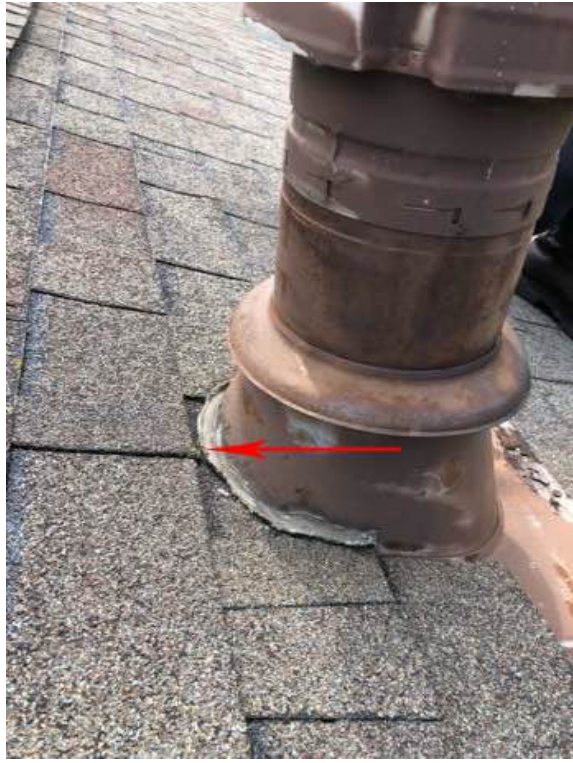
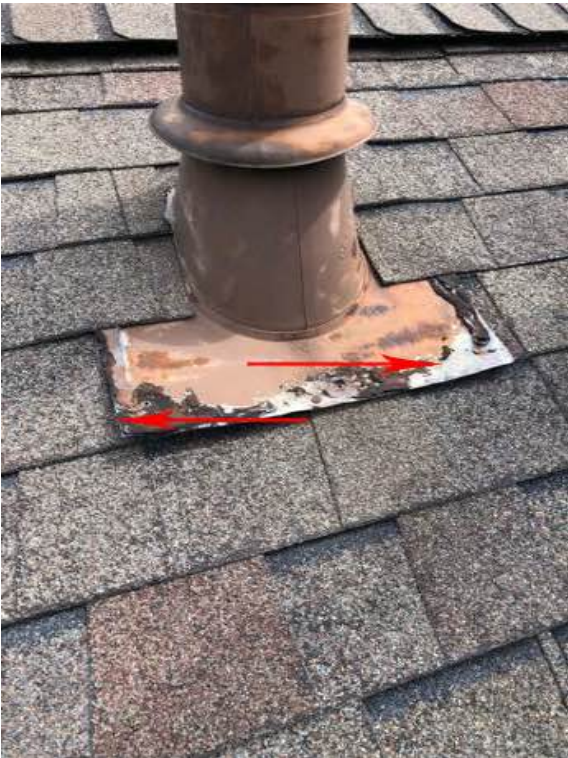
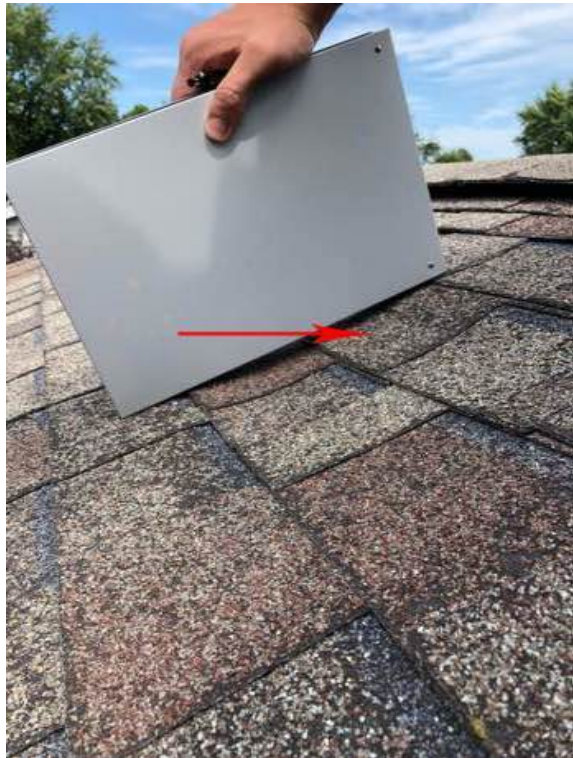
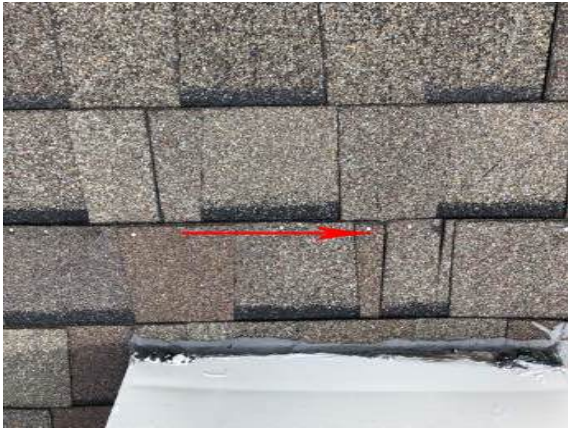
Minor damage to some shingles.

Caulk around the base of furnace vent penetration. Potential leak.

Missing nails at the corners of base flashing.

Soft spot on Northwest corner of roof, one foot from ridge vent and four feet from gable end. Appears to be from OSB patch in the plywood sheathing.

Exposed nail heads at the base of chimney. Potential leak.

Recommend further evaluation by qualified roofing contractor for all documented issues.

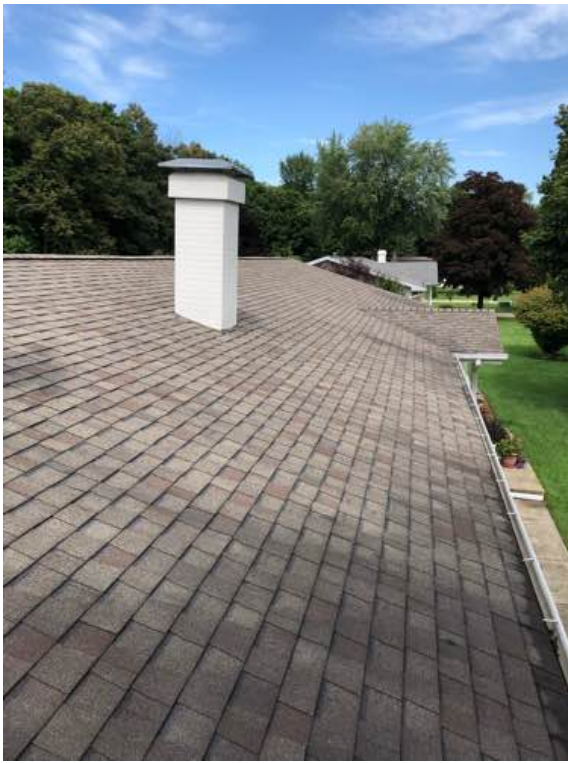
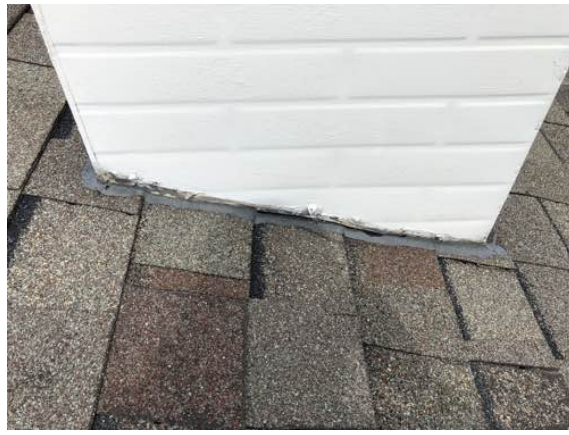
Inspected, caulk in place of base flashing. Potential leak. Recommend further evaluation by qualified roofing contractor.

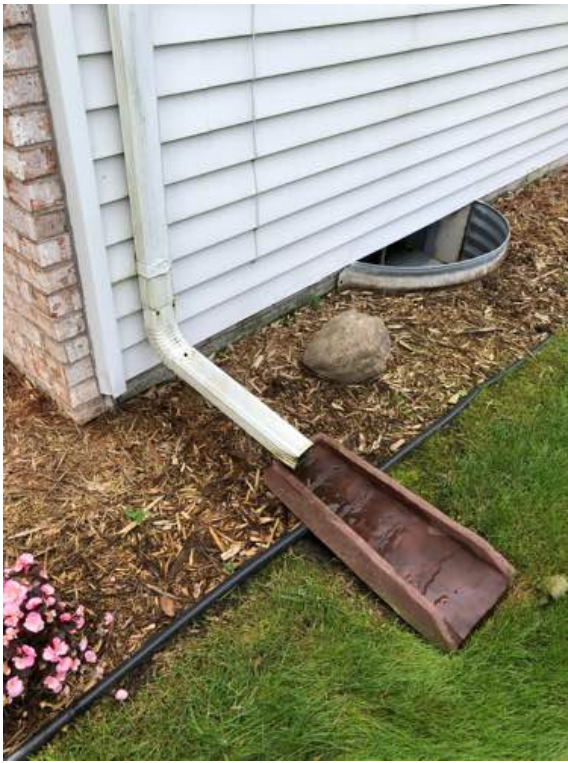
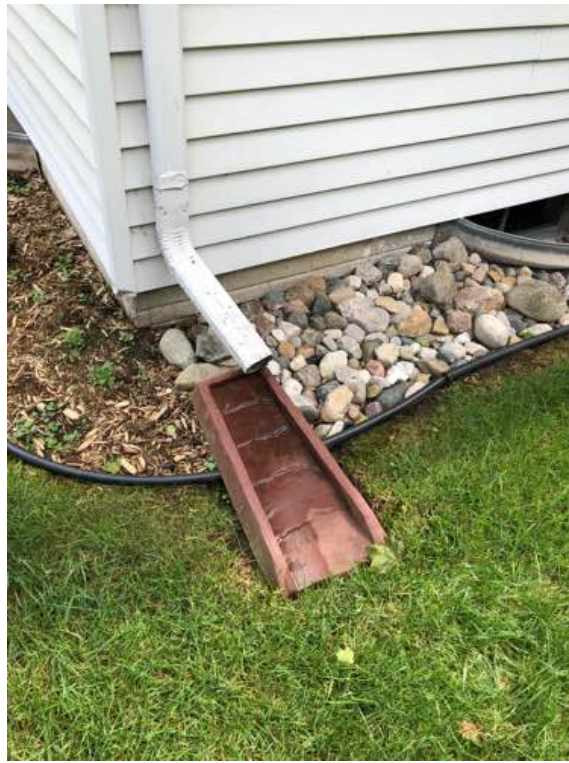
Gutters were in good condition around the entire perimeter of the roof. Would recommend downspot extensions five foot from base of house to prevent moisture penetration into basement as well as prevent foundation issues.

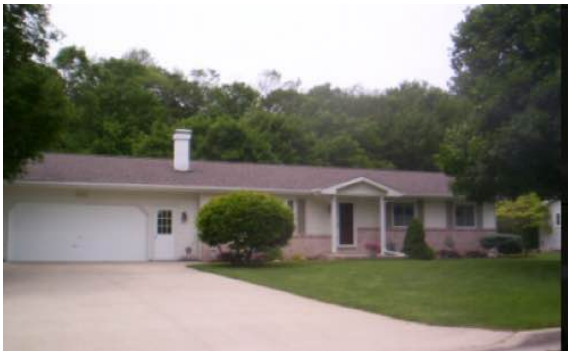
Aluminum siding with partial brick veneer on the face of house.

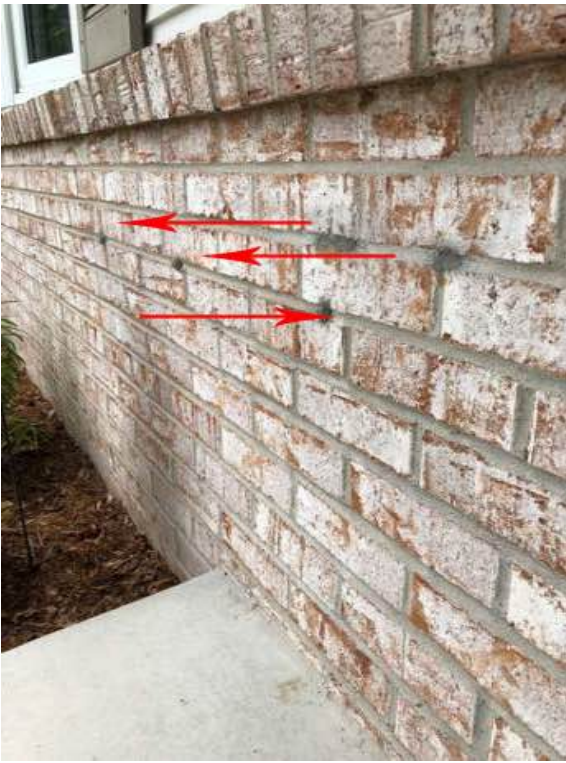
Owner stated that brick veneer was beginning to pull away from the house.

Corrective repairs have been made per the home owner.

Mortar patch holes visible where lag screws were used for repair.

Recommend further review by qualified mason.

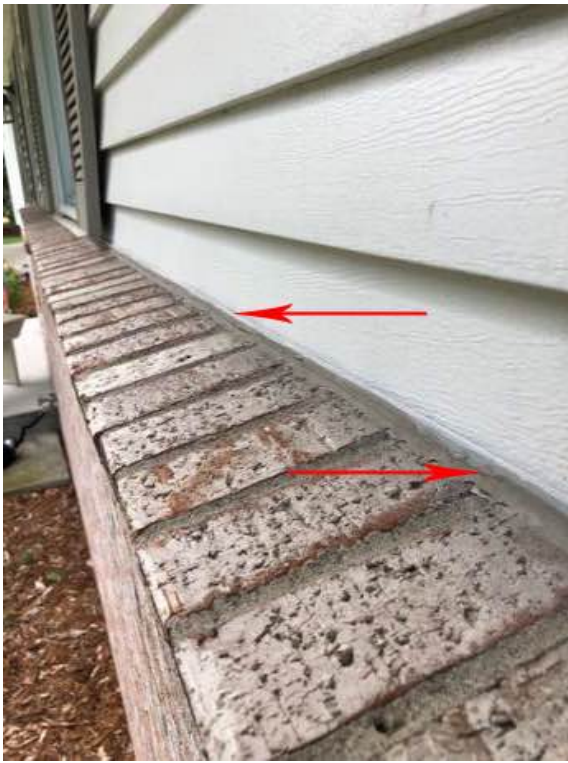
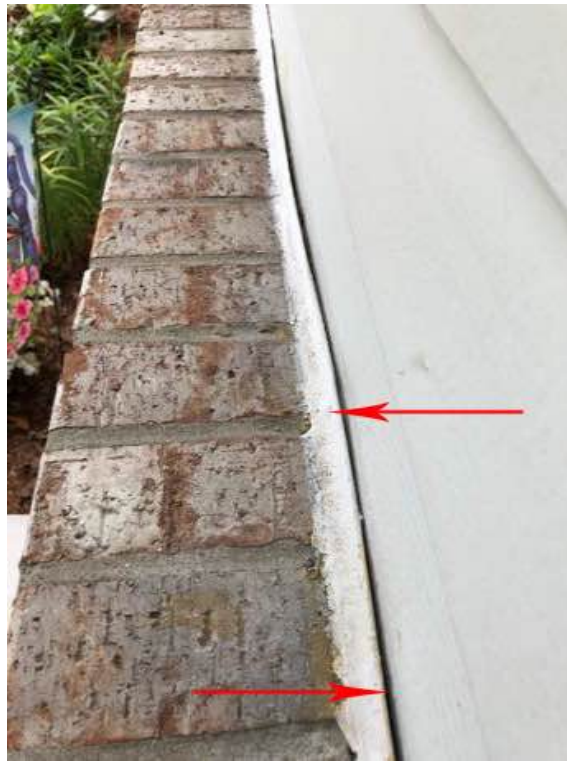
There does not appear to be any flashing in place to re-direct water from travelling down the siding and behind the brick veneer. It does appear that caulk has been used in place of flashing, but caulk bead does not appear to be water tight. Recommend further evaluation by a qualified carpenter.

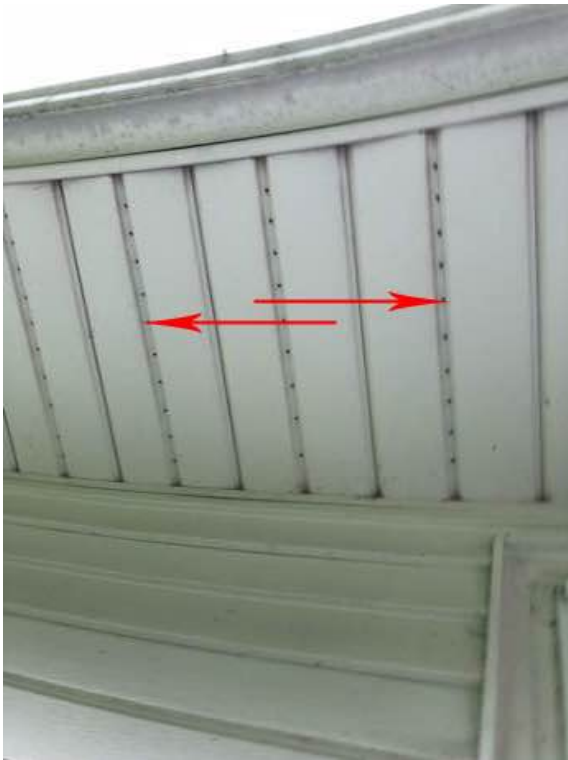
Soffit is vented to allow proper ventilation into attic and out of ridge vent.

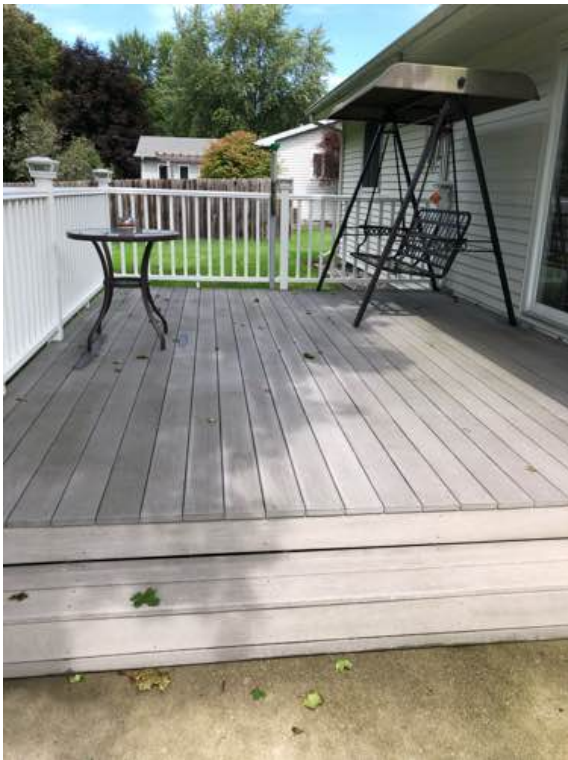
Deck appears to be solidly constructed and in good condition. Composite deck boards were used which should add significant longevity to the lifespan of the deck.

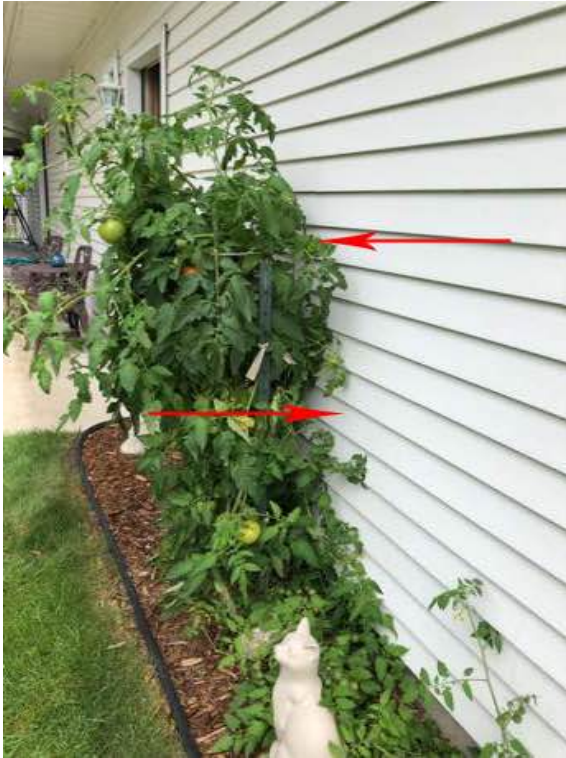
Vegetation was well kept, however would recommend at least 12" of clearance between vegetation and the side of the house.

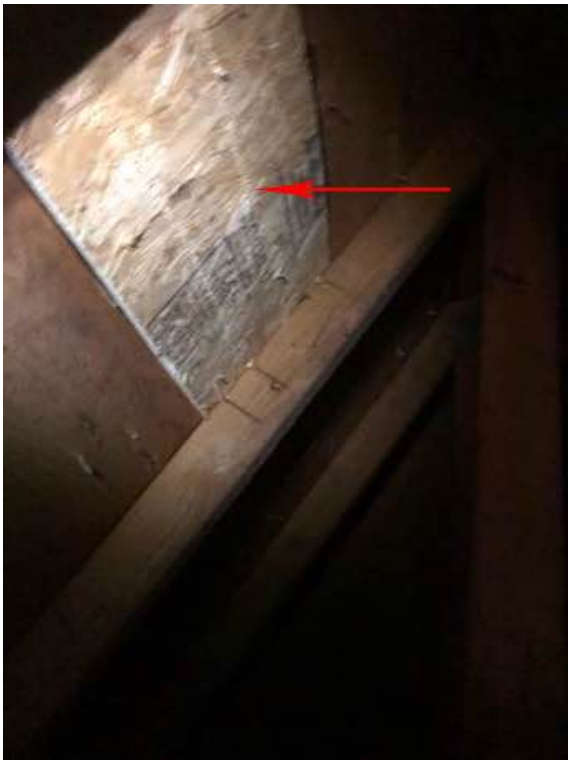
Plywood sheathing, in good condition. Several evident repairs have been made where plywood was cut out and replaced with OSB.

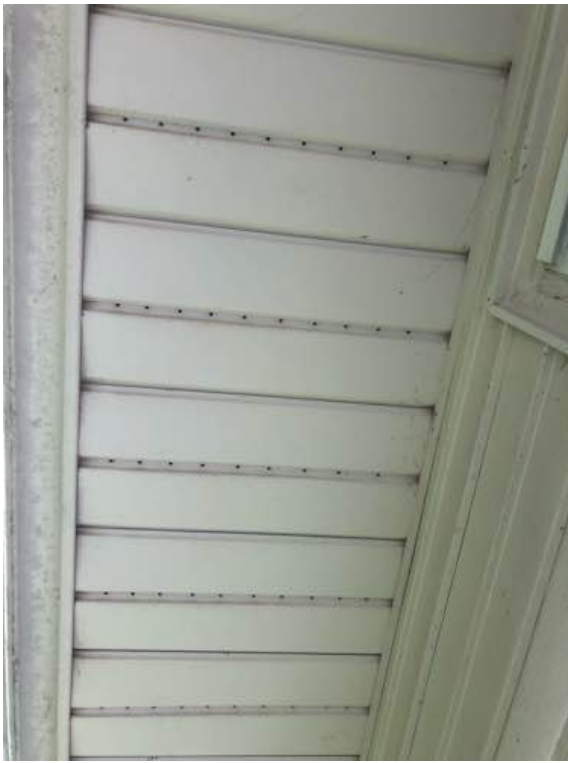
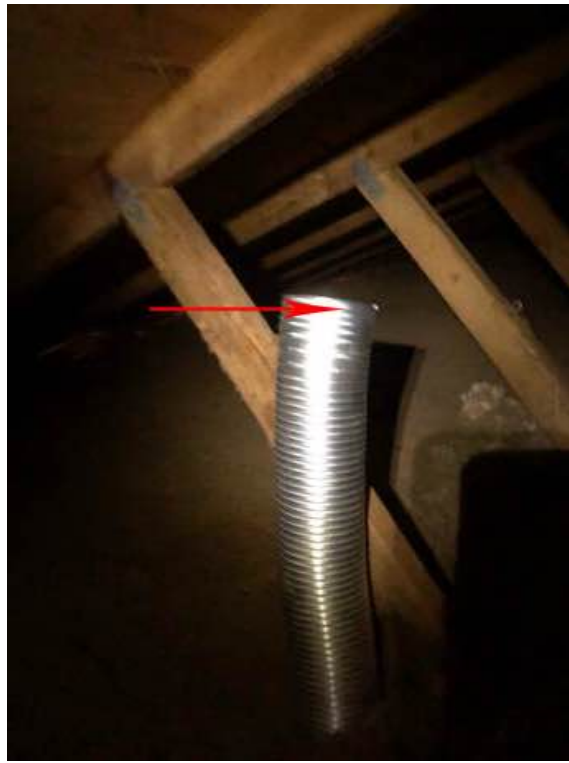
Vented soffit and continuous ridge vent in place.

Bathroom exhaust fan vent terminates in the attic. This is a potential moisture causing issue. Vent should terminate outside of the attic. Recommend qualified roofer for correction.

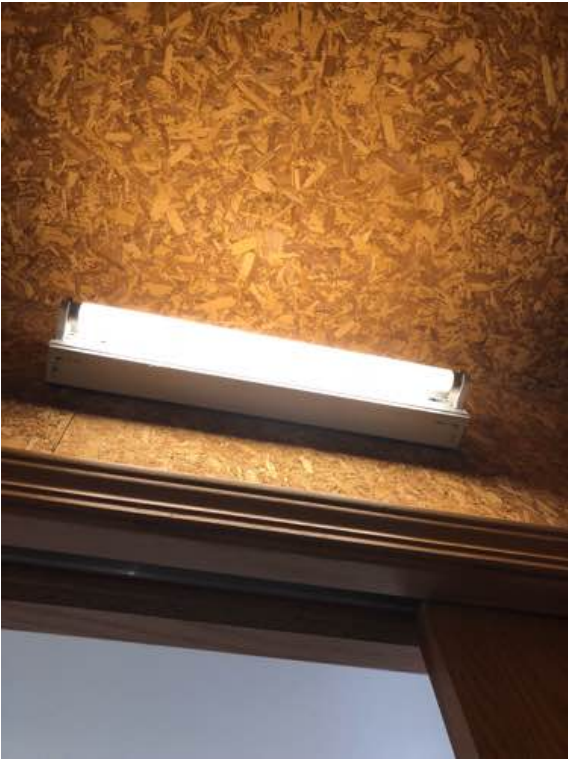
Walk in cedar lined closet with laundry chute. Proper lighting installed. Recommend fire barrier be installed on chute between main floor and basement.

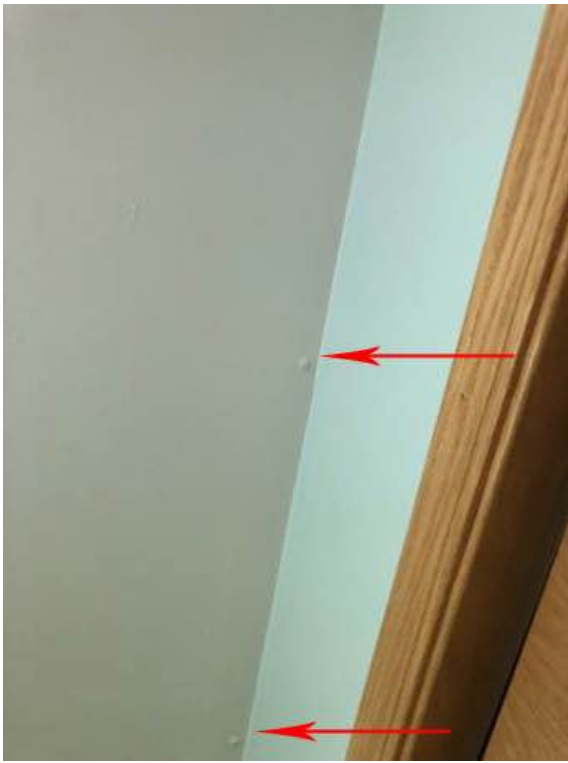
Several nail pops noticed in ceiling near closet. Cosmetic issue only.
Recommend qualified carpenter or handyman if correction is desired.

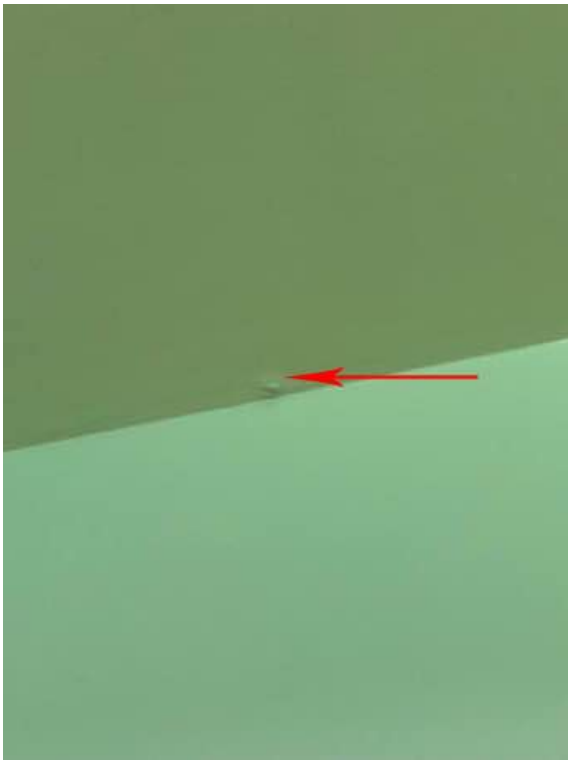
Several nail pops noticed in ceiling near West wall. Same recommendation as with nail pops mentioned in bedroom 2.

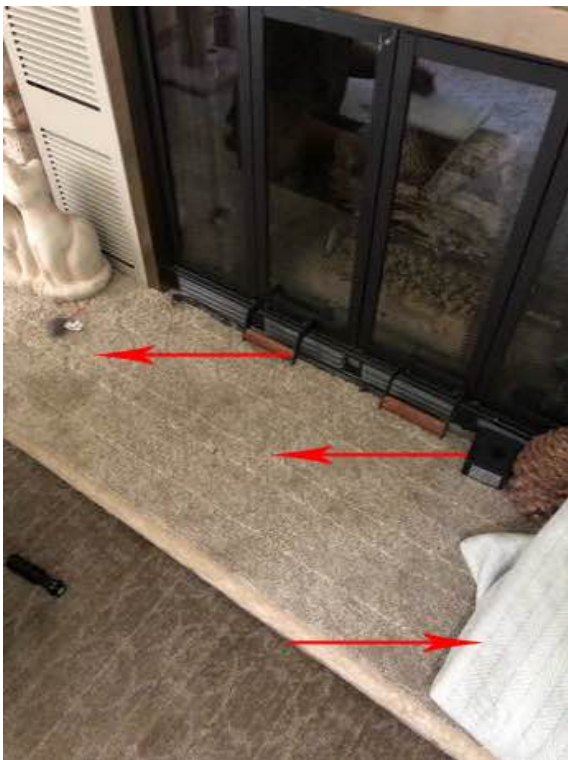
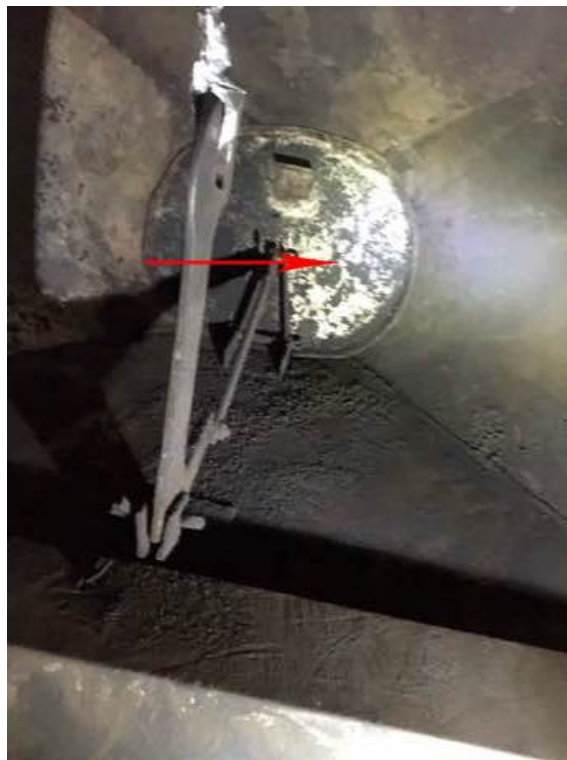
Gas log fireplace, functioning and in good condition. Flue appeared to function properly.

Would recommend removing carpet remnant/runner from the hearth for safety. Potential fire hazard.

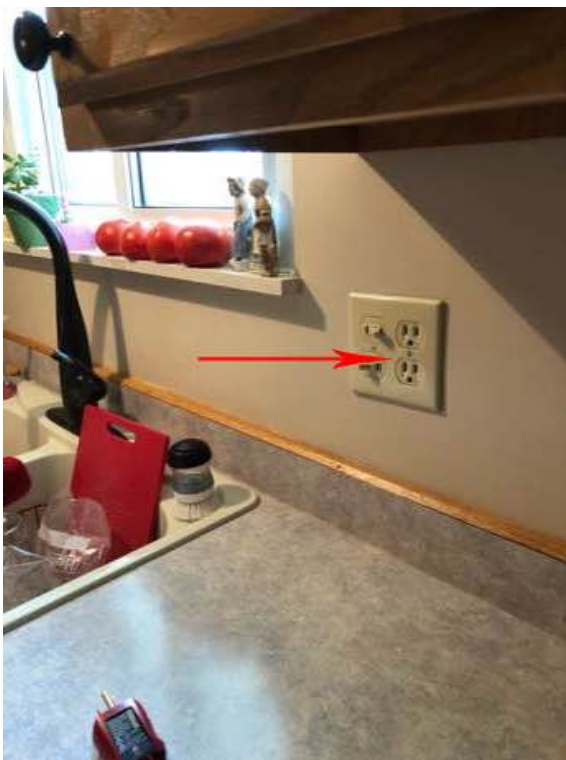
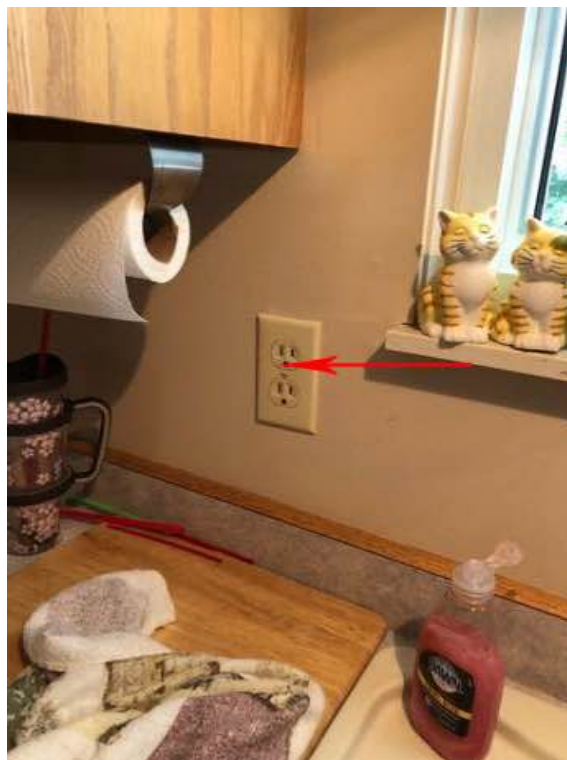
Inspected. Outlets were grounded but were not GFCI near sink. Potential shock hazard. Recommend further evaluation by licensed electrician.

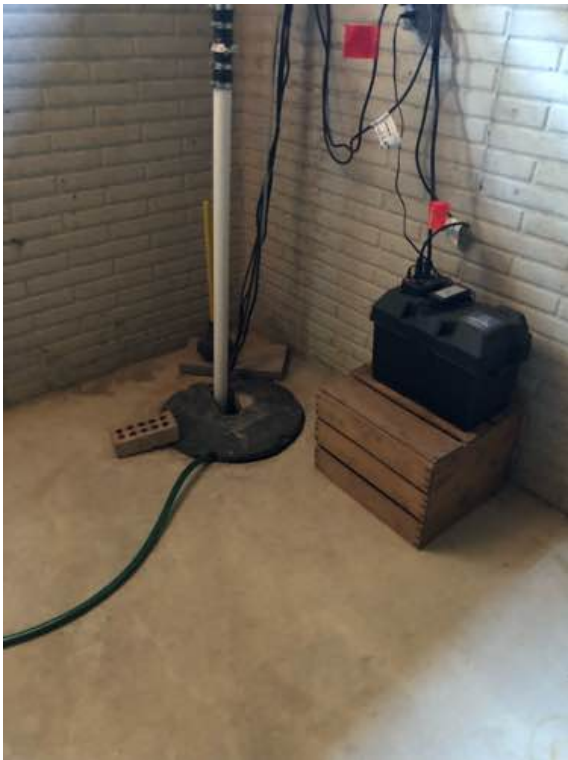
Sump and backup sump in crock. Battery backup system is installed to run pumps during power outage.

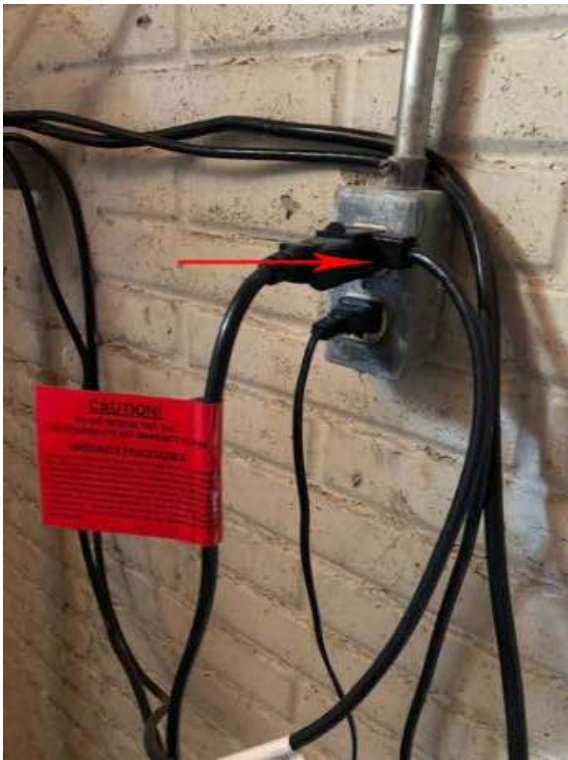
Outlet near sump is not GFCI protected. Potential shock hazard. Recommend further evaluation by licensed electrician.

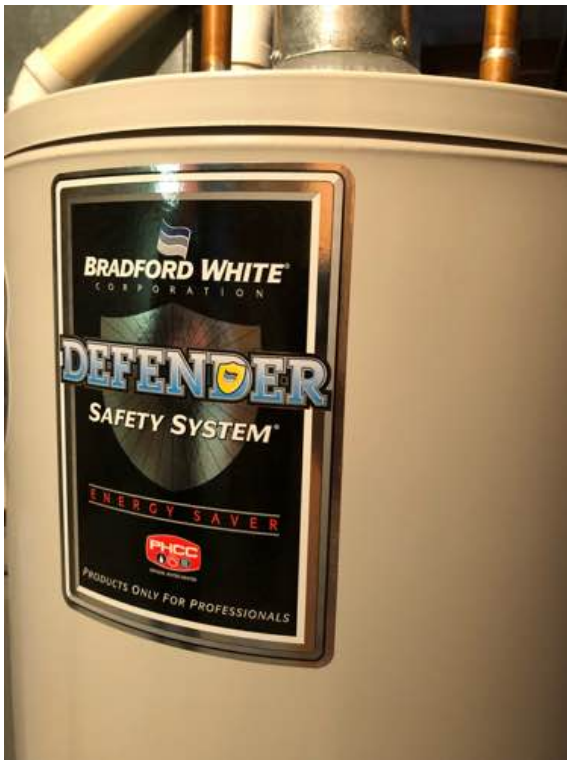
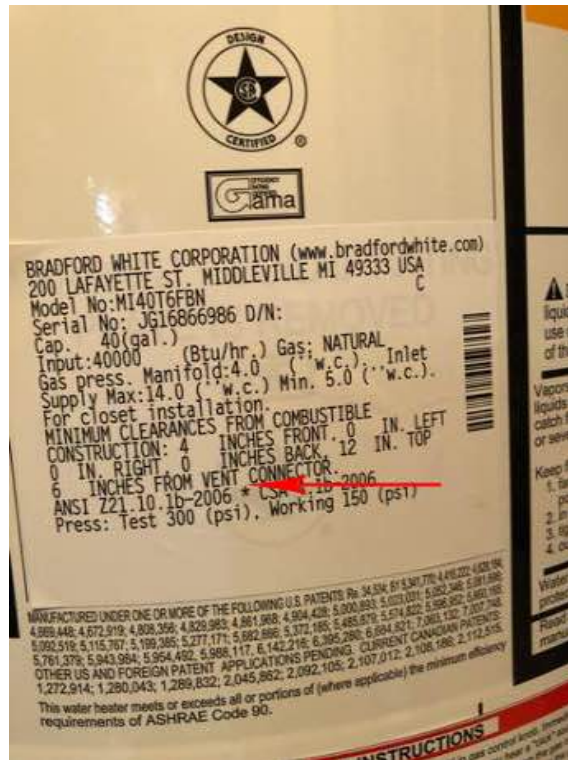
Inspected. Venting system appears to have adequate clearance from combustibles. Date of manufacture of unit post 2006.

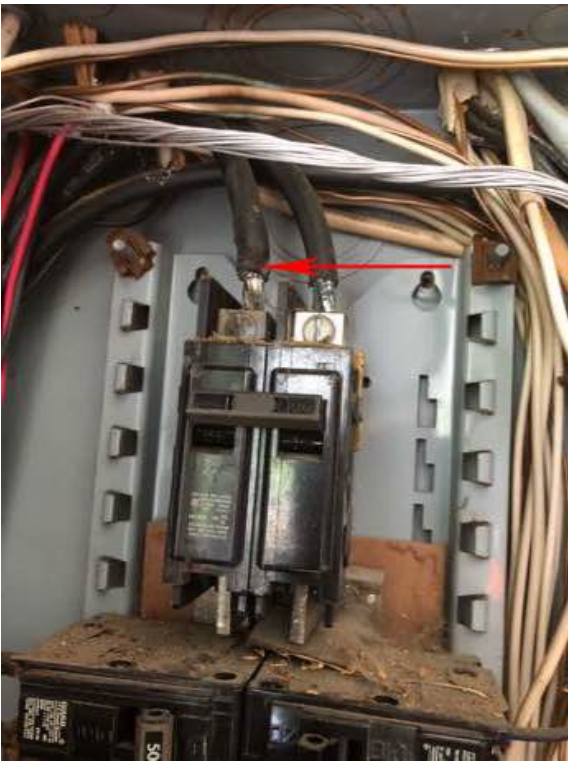
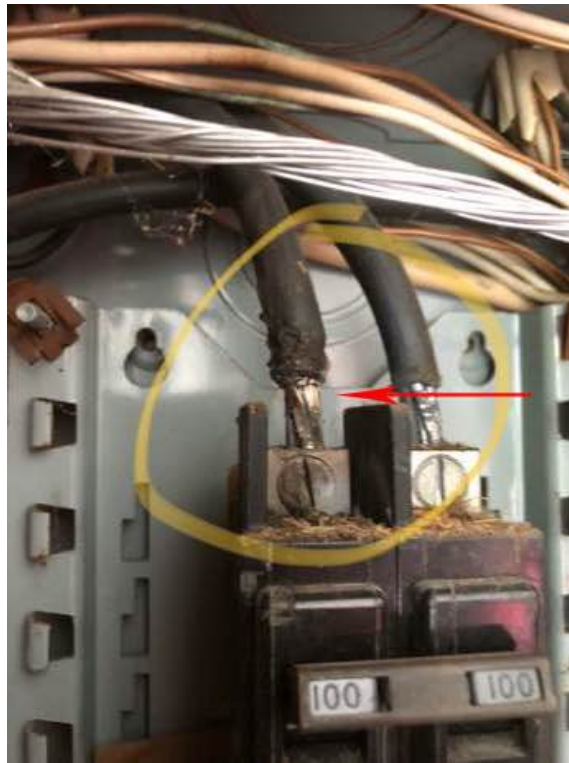
Noticed arcing on service wiring into the main disconnect. Potential fire hazard. Recommend further analysis by licensed electrician.

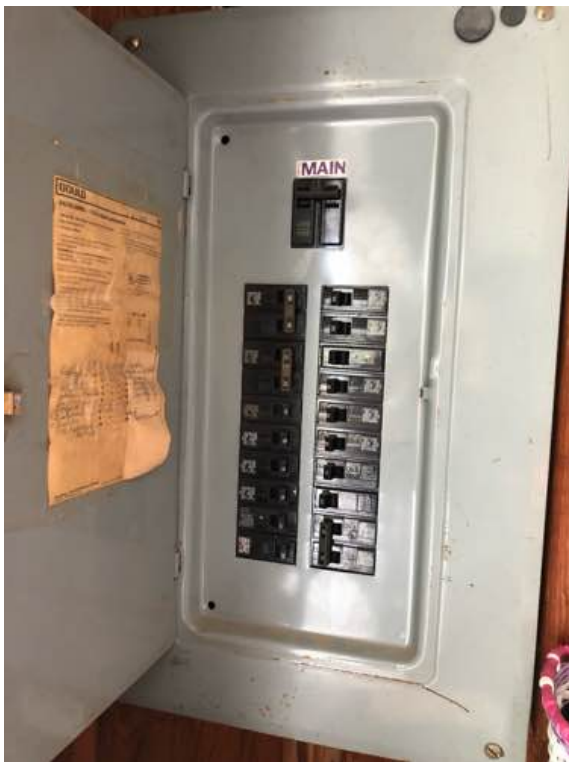
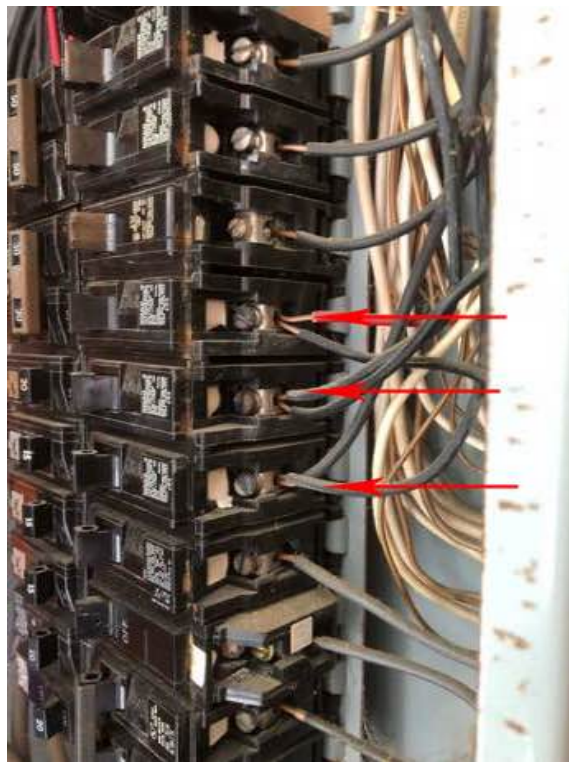
Inspected. In Fair condition, however several double taps were noted on circuit breakers. Potential for loose wires and arcing resulting in fire. Circuit breaker is not intended to hold more than one conductor.

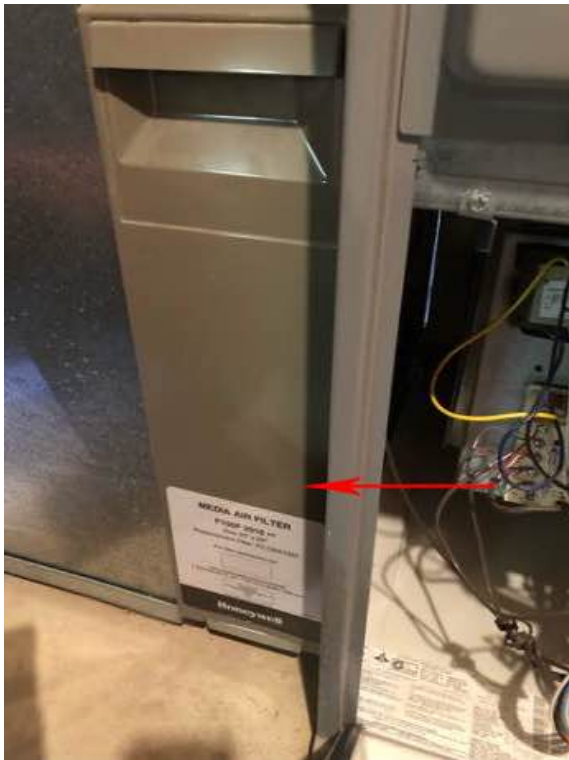
Air filter located on West side of furnace. Recommend checking condition of filter every several months and replacing filter according to manufacturer's recommendation.

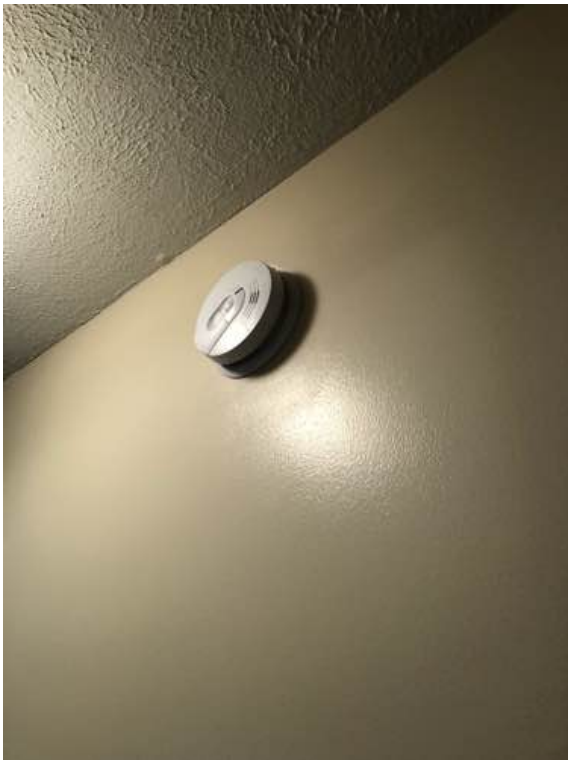
Alarm was installed, in apparently good condition, but not tested.

Recommend installing smoke alarms in all bedrooms.

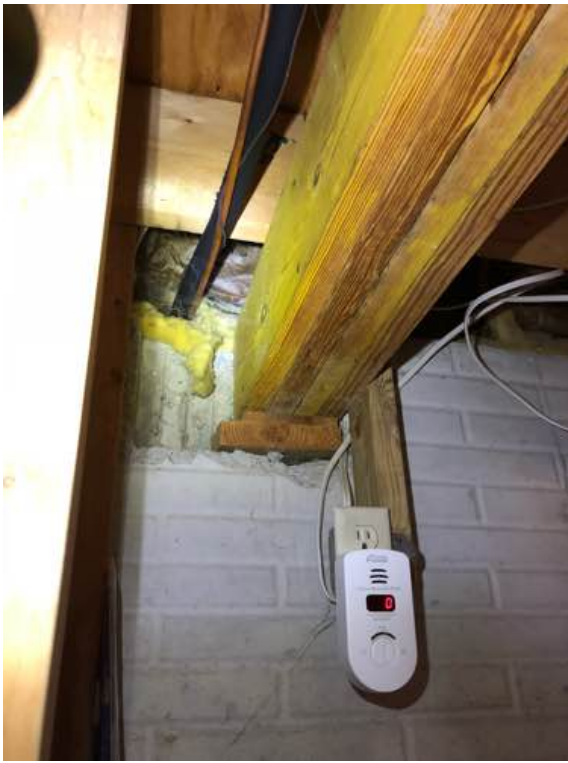
Inspected, but not tested. Appeared to be operational. Would recommend installing another unit on main level bedroom hallway.

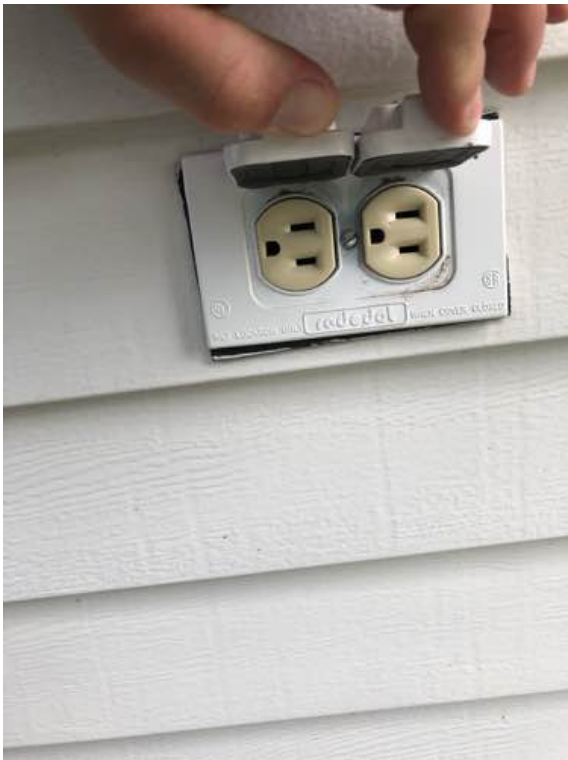
External outlet on back side of house was operational and grounded, but nit GFCI protected. Potential shock hazard. Recommend further evaluation by a licensed electrician.

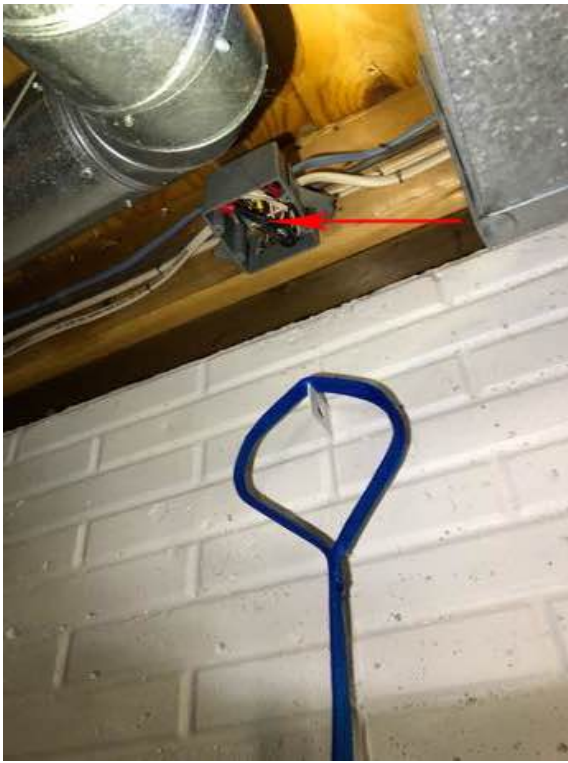
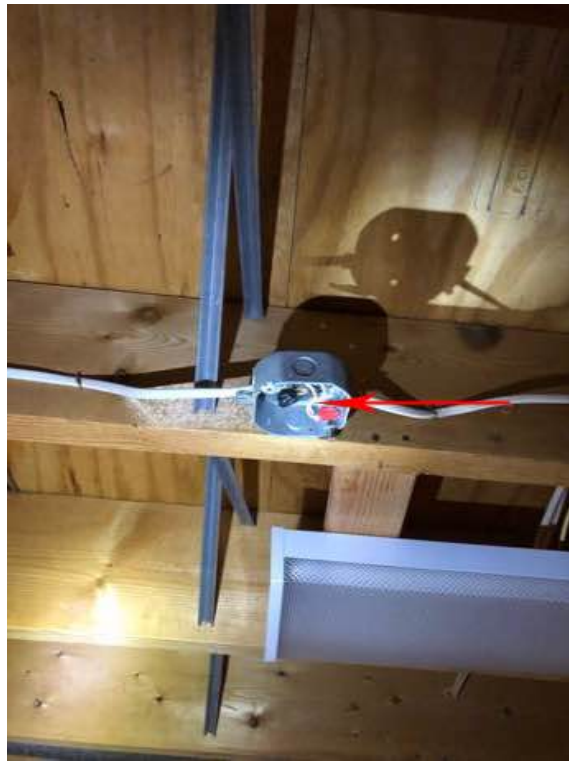
Several open electrical junction boxes were noted in basement. Potential safety issue having exposed live wires. Recommend installing appropriate covering.

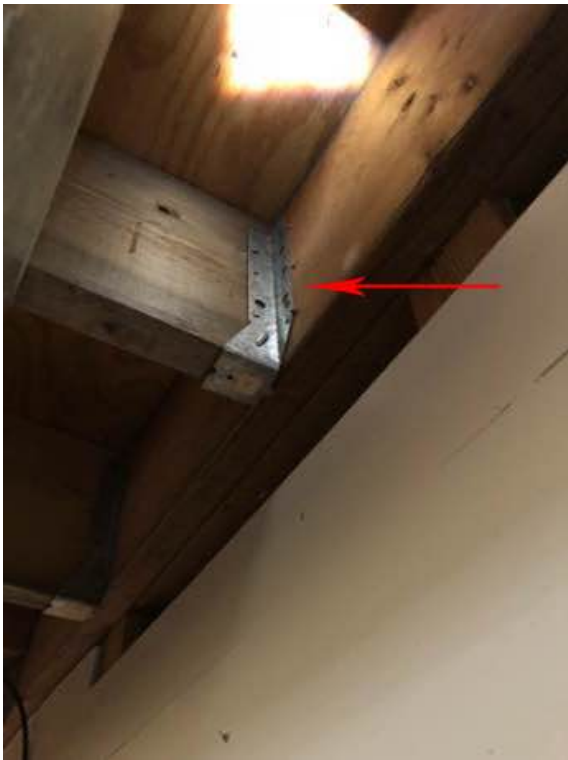
Several joist hangers did not have all nail holes utilized. Could potentially result in shifting of floor. Recommend a qualified carpenter or handyman to replace nails.

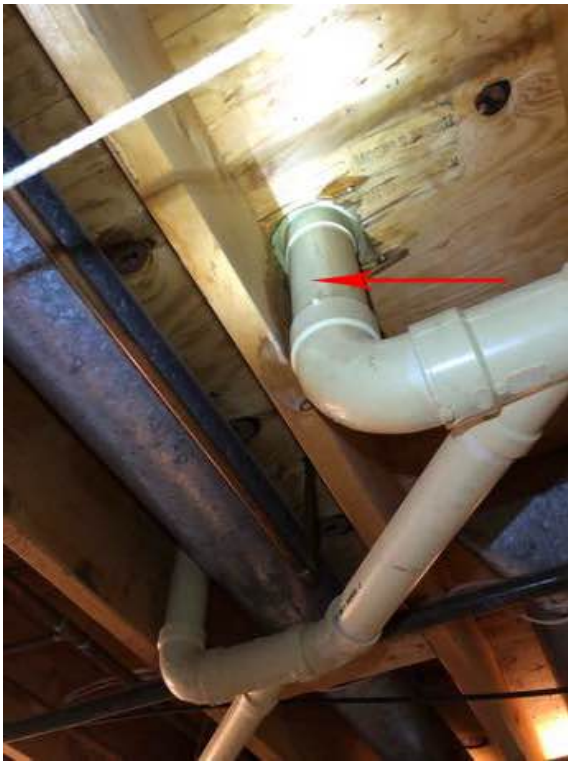
OLD POTENTIALLY CORRECTED TOILET WAX RING LEAK.

Staining from a past wax ring leak on toilet noticed on floor joist under master bath. Recommended asking current owner if this has been repaired. Stain was dry at the time of inspection.

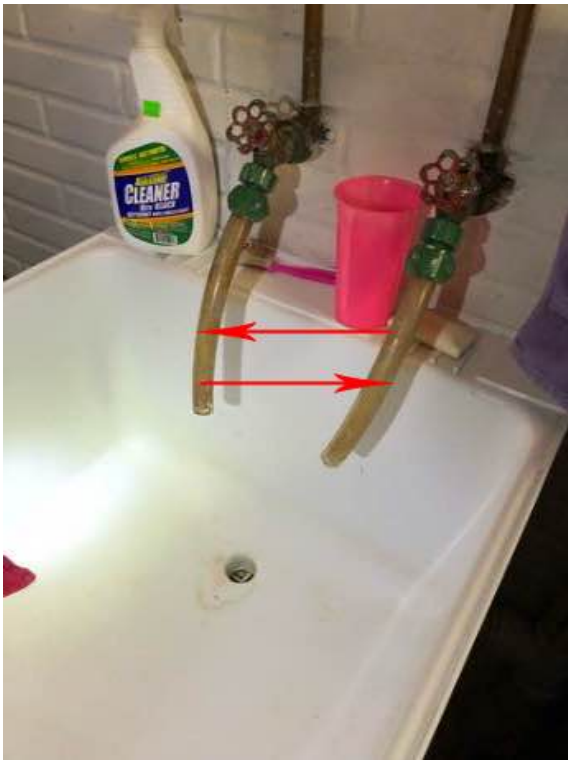
Potential cross contamination issue. Hoses on faucet should not extend into the wash basin portion of the sink. Recommend trimming or removing hoses.

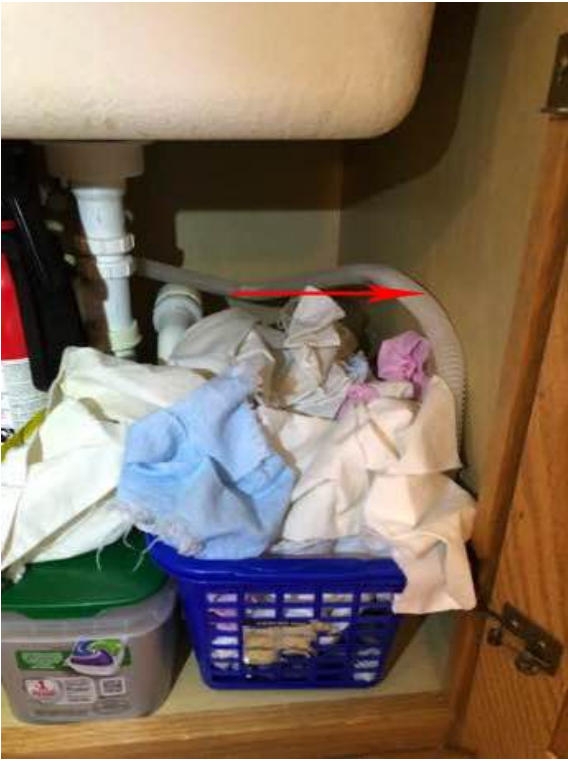
Dishwasher discharge line should have a high loop installed to help prevent backflow into the dishwasher itself. Potential for bacterial contamination. Recommend review by licensed plumber.
