# Great Lakes Home Inspectors

**September 6th 2018, 1:45 pm**

**BUILDING ADDRESS:** 1234 Sample St  
**CITY:** Saginaw  
**STATE:** MI  
**ZIP CODE:** 48601  
**INSPECTION DESCRIPTION:** Ranch-style house with 2-car attached garage

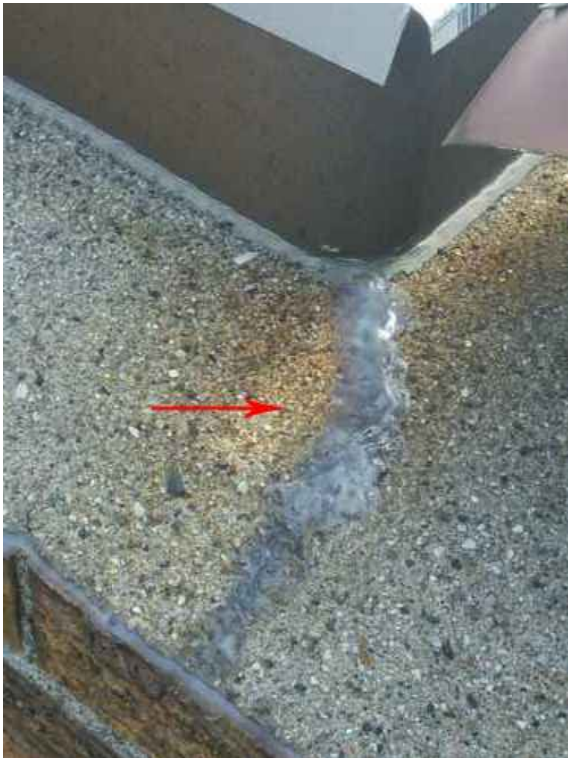
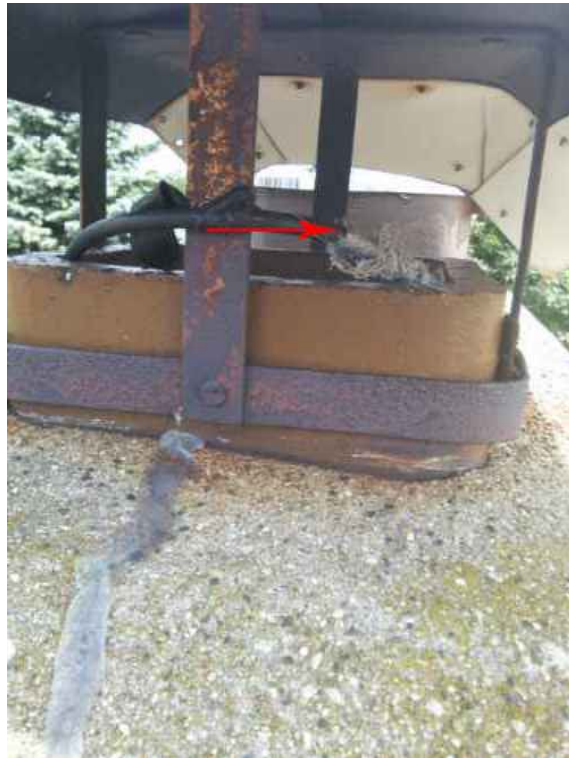
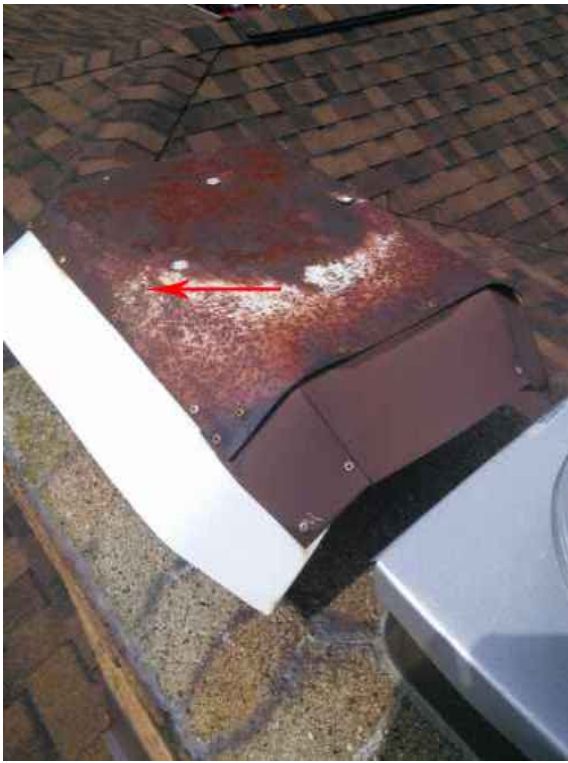
Fair

Chimney crown appears to have cracked and was repaired with caulk. No leaks were present at the time of the inspection.

Chimney has a cable that is run down through it. Consider adding mesh to the opening to keep pests out in the future.

Chimney cap is rusty and passed its predicted life.

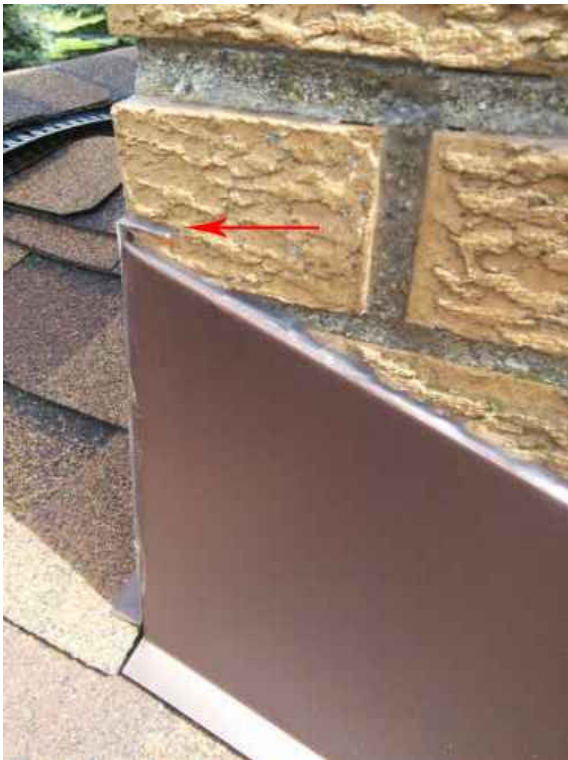
Flashing was installed on the chimney with reglets cut in. This provides optimal moisture protection.

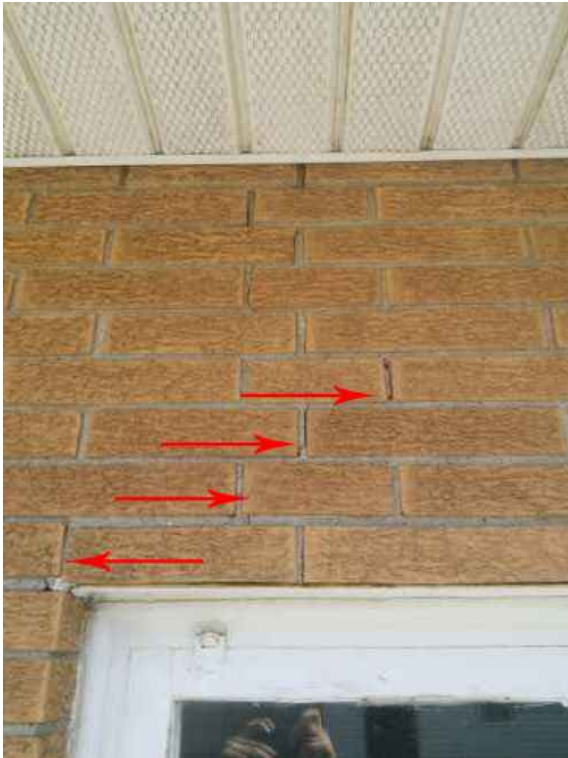
Vertical cracks in the brick above the west window of the garage. Vertical cracks are typically only a cosmetic issue. Continue to monitor.

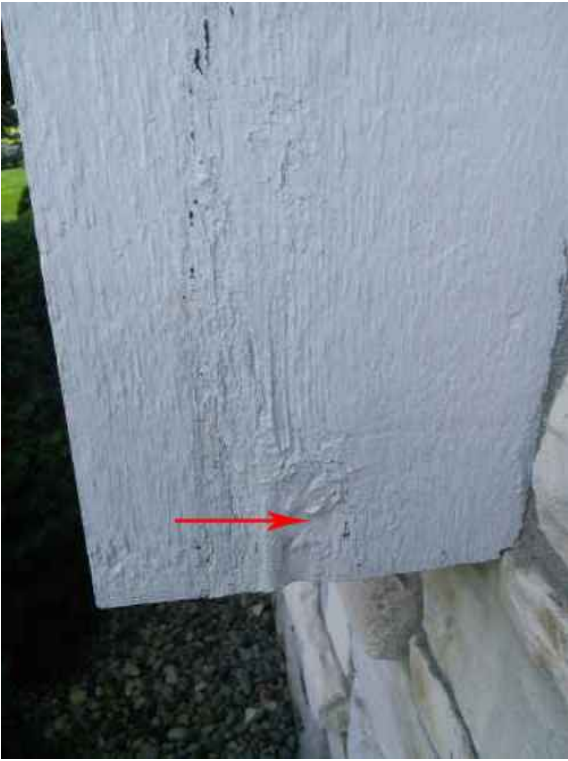
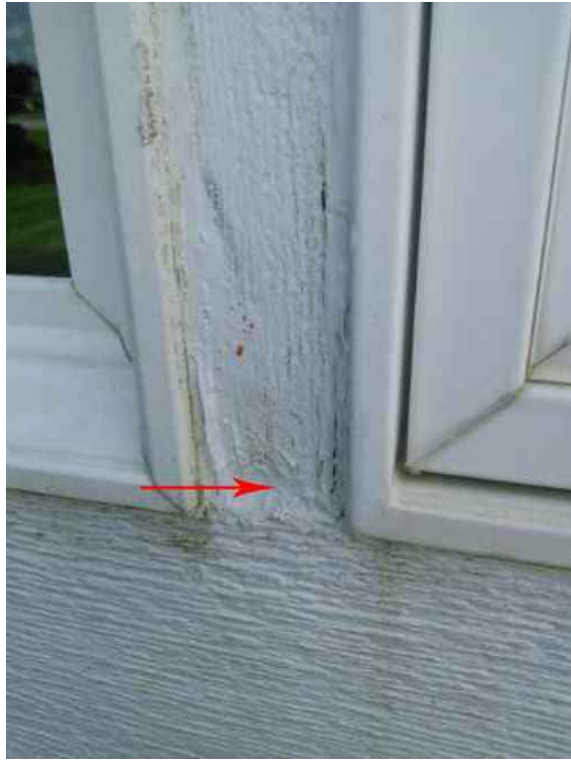
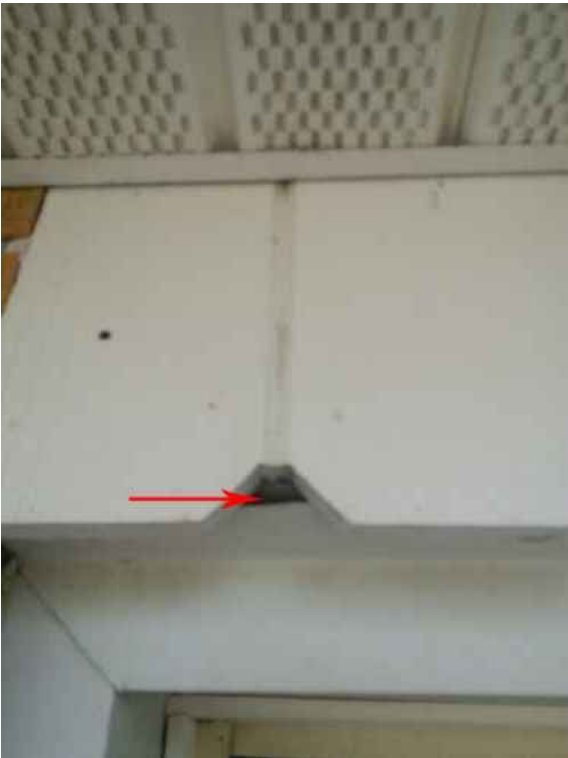
Poor

Several areas of the wood trim around the front living room windows are soft and potentially rotted. Recommend further evaluation by a qualified carpenter.

There is a small gap between the trim work above the garage door. This can lead to potential moisture or pest issues. Recommend further evaluation by a qualified carpenter.

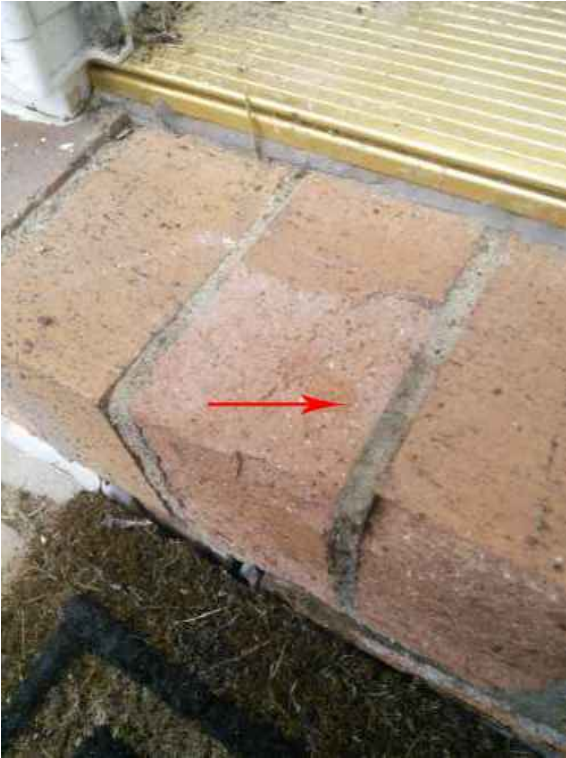
Spalling of the bricks at the base of the door to the rear of the garage.  
This is caused by moisture issues, recommend further monitoring.

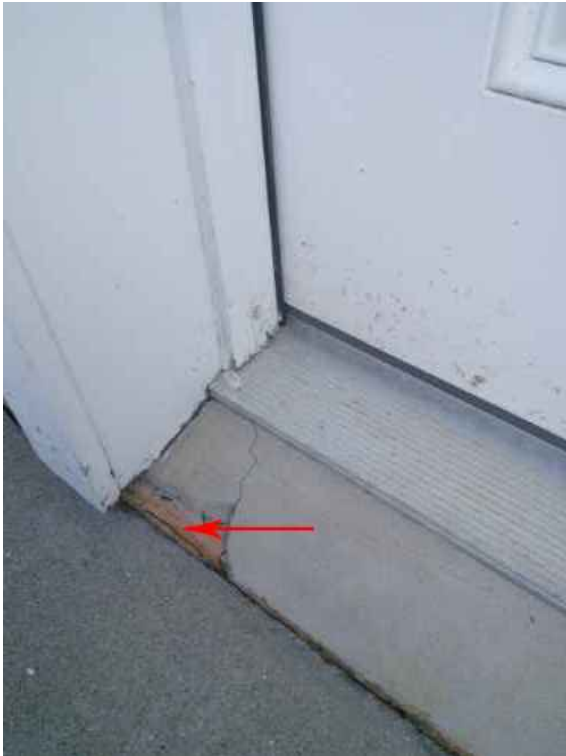
Cracking of the west man door threshold. Continue to monitor.

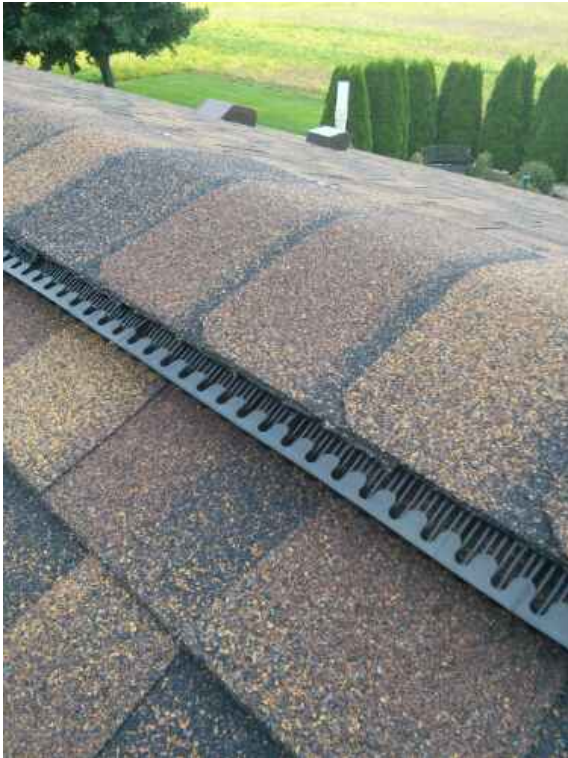
Continuous ridge vent with continuous vented soffit.

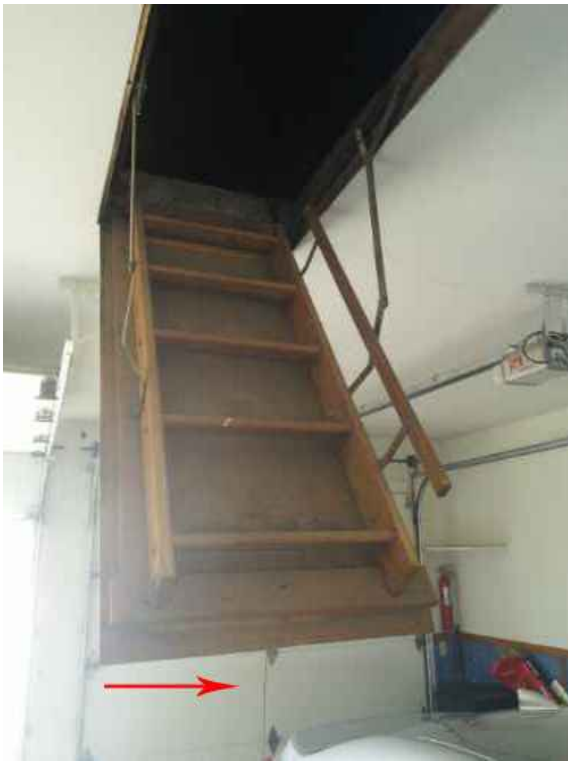
Attic access is in the garage with a pull-down ladder. Bottom half of the ladder is missing, recommend further evaluation by a qualified carpenter.

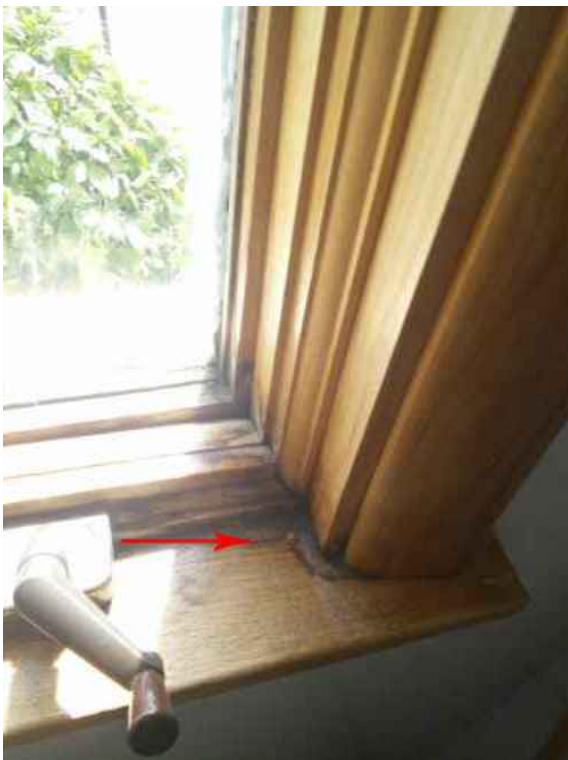
"Dark staining substance" appears to be present. Continue to monitor window for potential moisture issues.

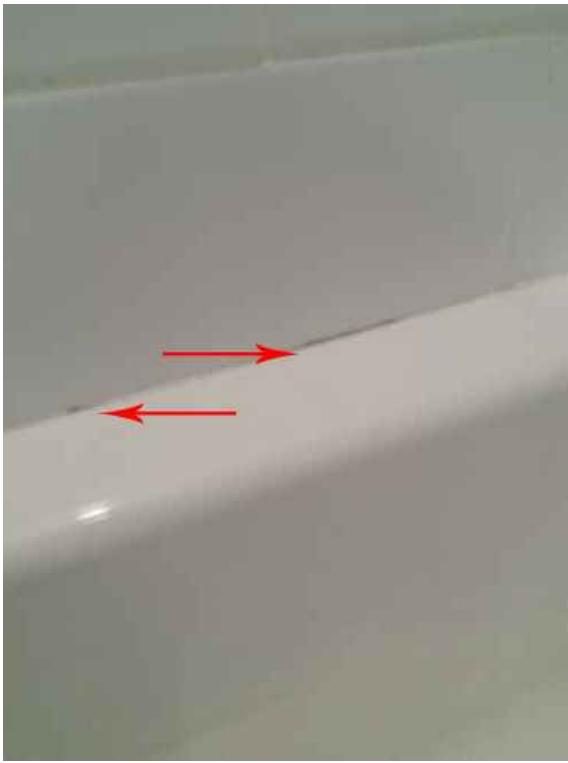
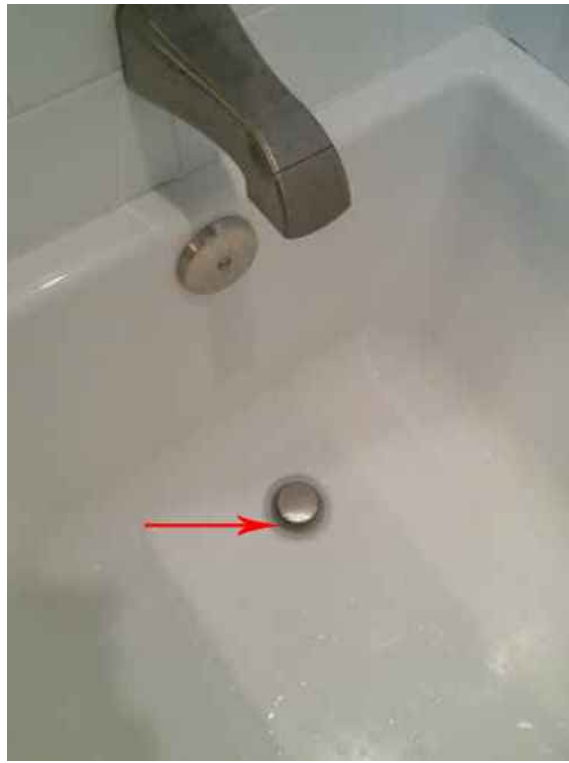
Gaps in the grout where it meets the bathtub. This is a potential moisture issue. Recommend adding caulk to prevent moisture issues.

Tub water-stopper will not lock in the down position to allow the tub to fill. Recommend further evaluation by a licensed plumber.

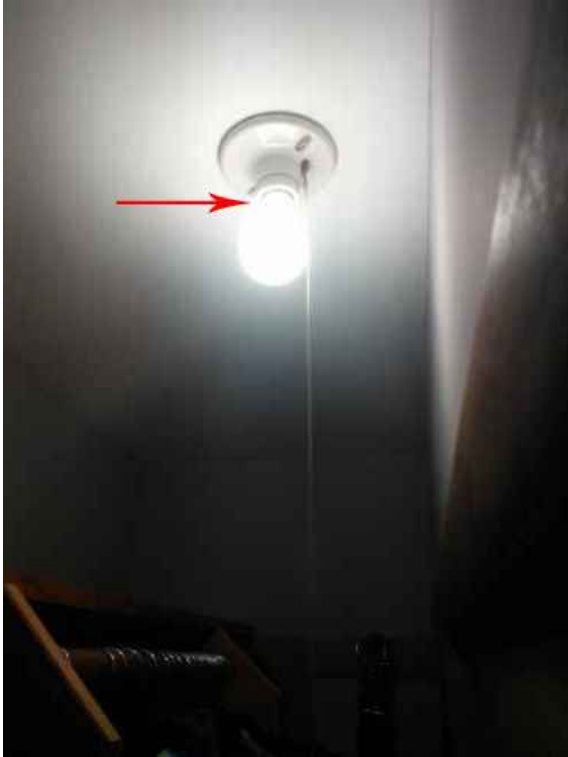
Exposed incandescent lighting is present in the closet. This can be a fire hazard if flammables come in contact with the bulb. Recommend changing to a low profile i.e. fluorescent light to avoid potential fire hazards.

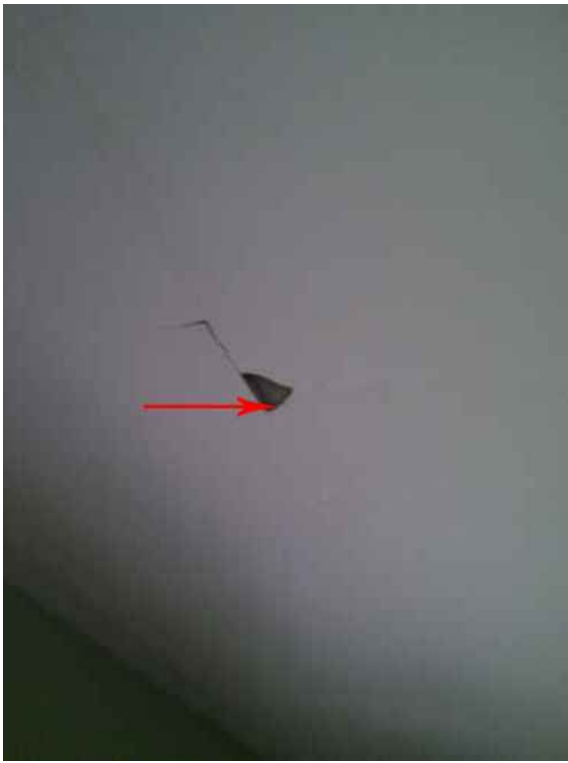
Poor

Delamination of the ceiling is occurring from a possible moisture issue. No moisture was present at the time of the inspection.

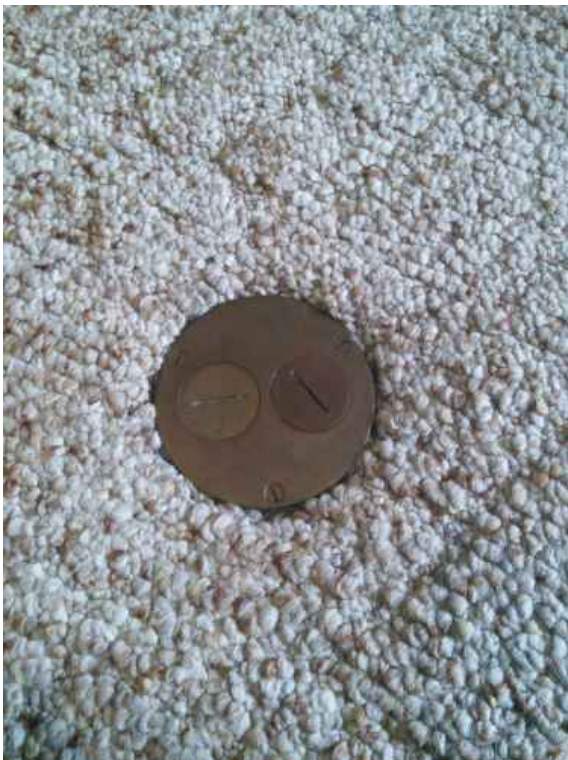
These are floor mounted electrical outlets in the middle of the living room for additional electrical needs.

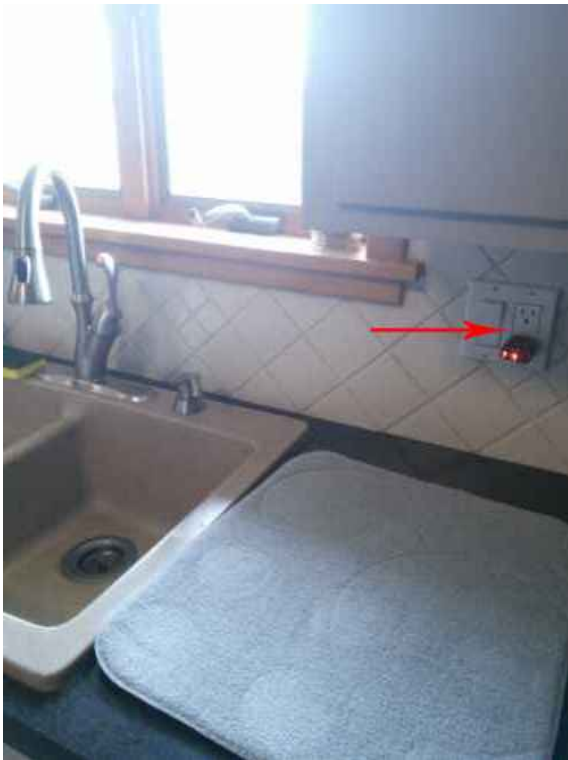
No garbage disposal is installed.

The outlets on either side of the sink are not GFCI. This is a shock hazard. Recommend further evaluation from a licensed electrician.

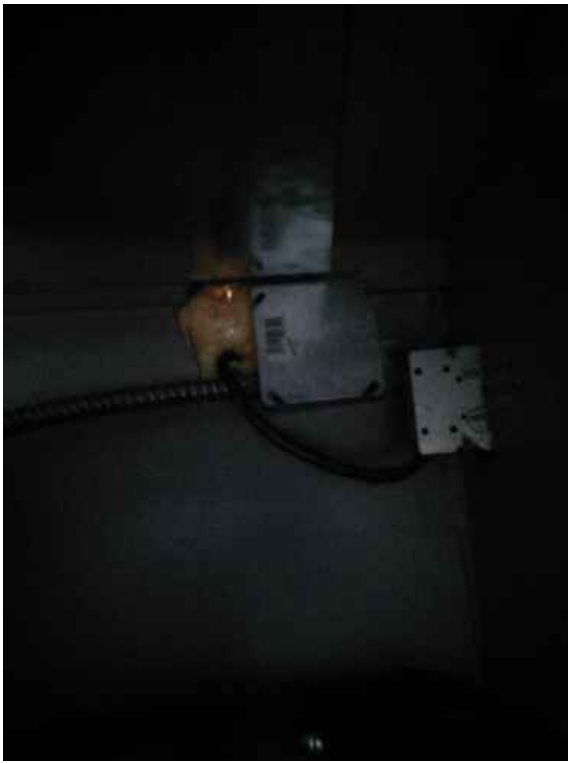
**The stove electrical penetration is not completely sealed off from the garage. Recommend adding insulation for futher energy efficiency.**

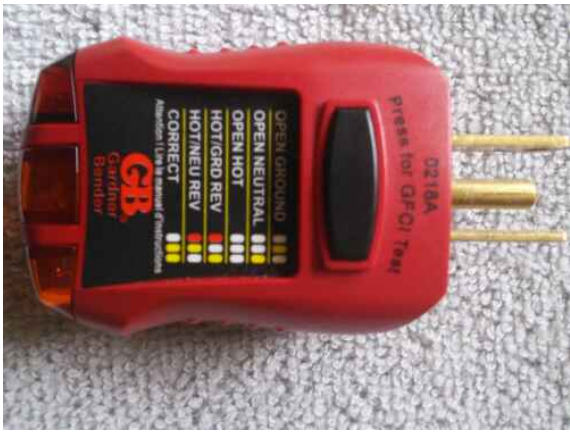
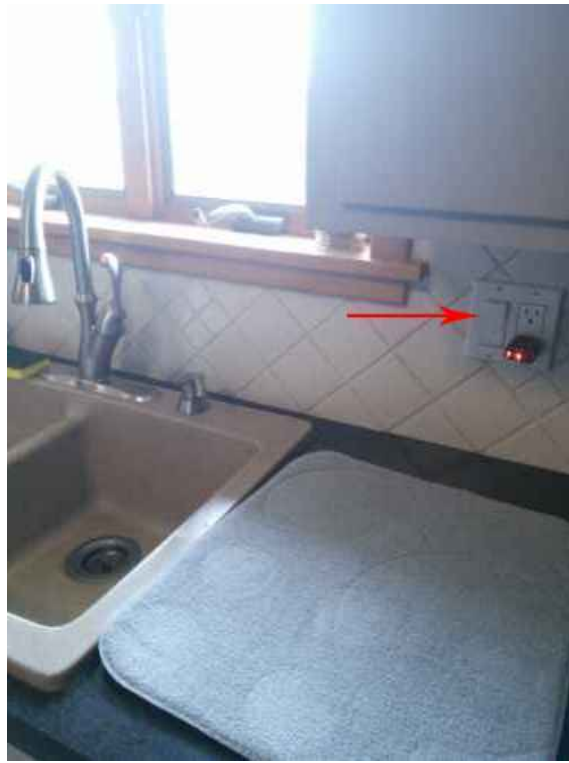
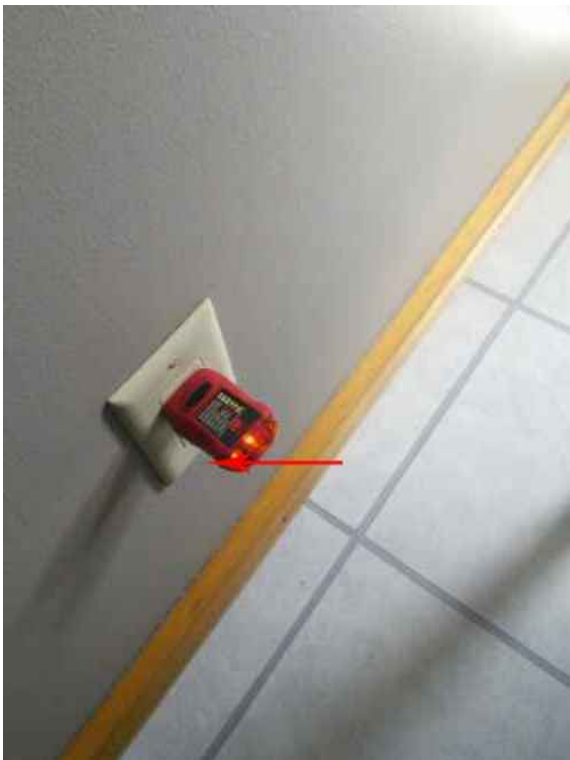
Poor

There are multiple outlets throughout the kitchen that have the hot/neutral wire reversed, as indicated with the electrical outlet tester. Sink does not have GFCI outlets installed on either side. These are potential shock issues, recommend further evaluation from a licensed electrician.

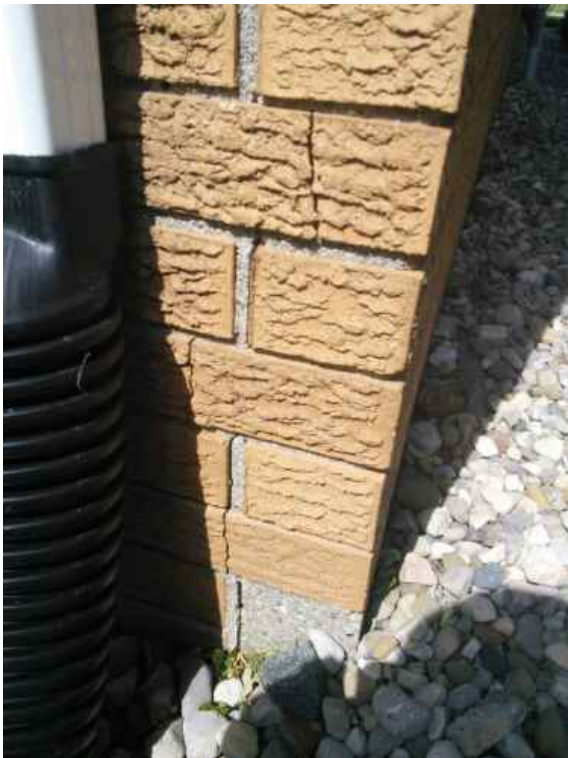
Several vertical cracks were noted in the SE corner of the house. This could have been caused by poor gutter drainage. Continue to monitor for further cracking or shifting.

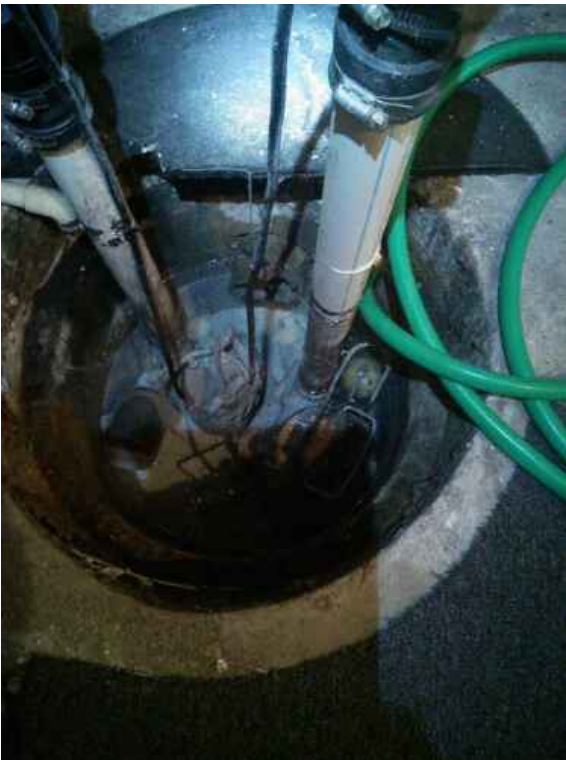
Sump pump with backup pump installed. Recommend adding cover to the sump pit for added safety.

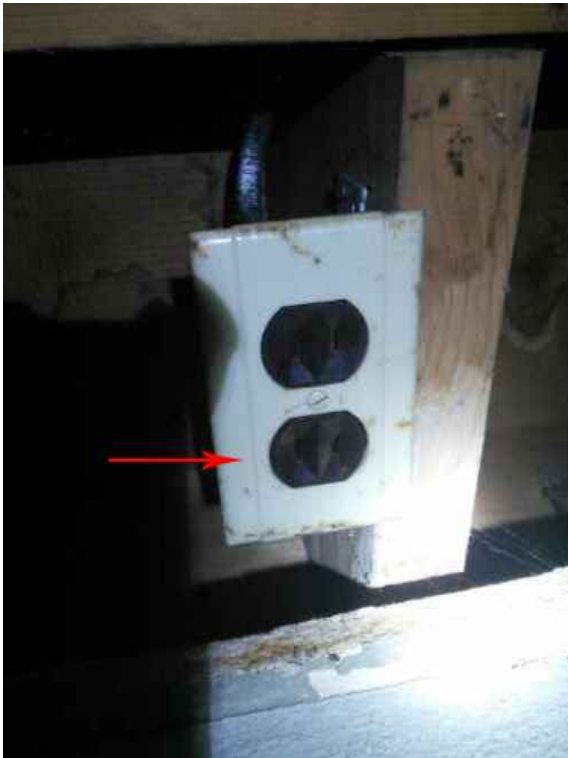
There are several outlets in the basement that do not have a ground installed. These are potential shock hazards, recommend further evaluation by a licensed electrician.

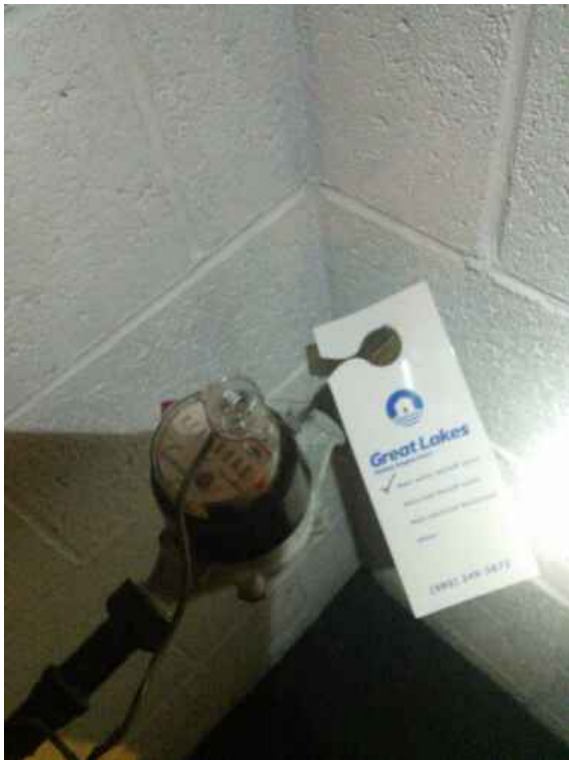
Main water shut off is present in the basement and is identified with a tag.

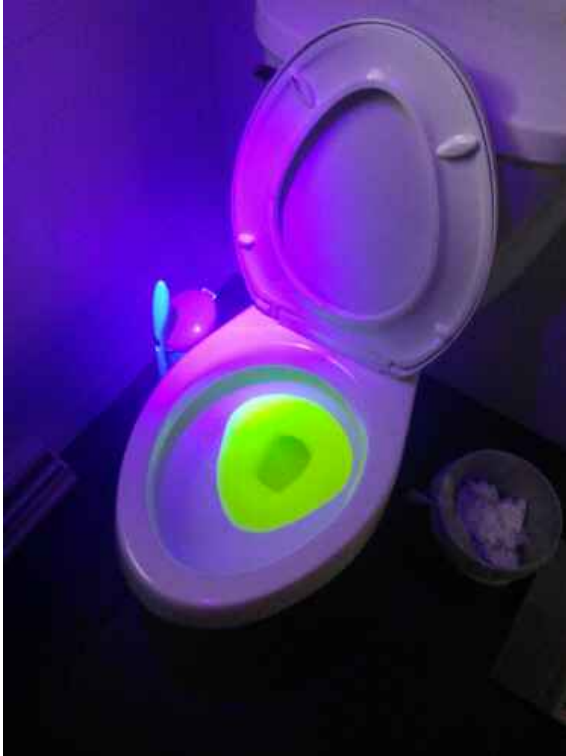
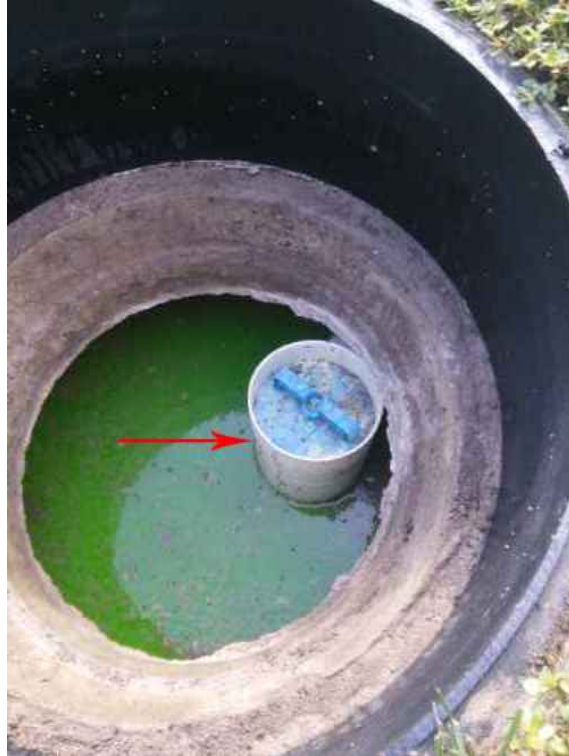
Septic system. Added leak detection dye at the toilet and ran approximately 500 gallons to perform a flow test on the system. No dye was present after the flow test indicating the leach field is functioning as designed. Recommend yearly cleaning of the discharge filter to prevent clogging of the system, located under the west manway cover.

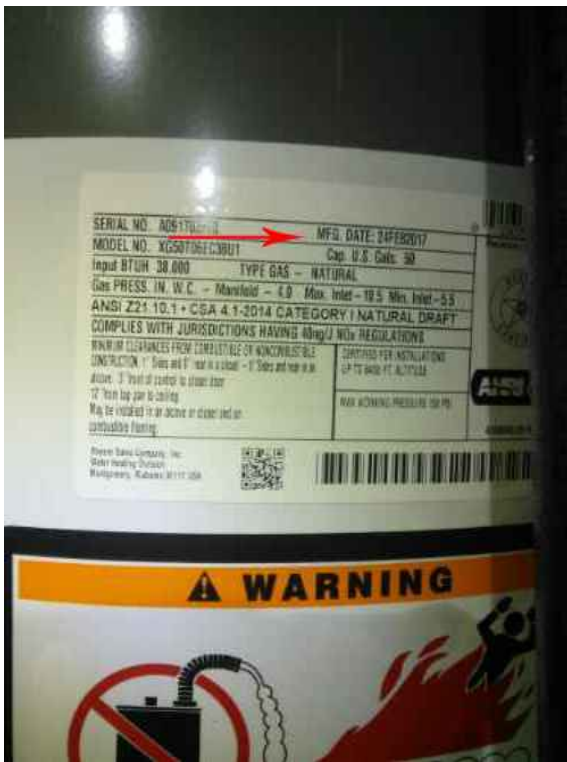
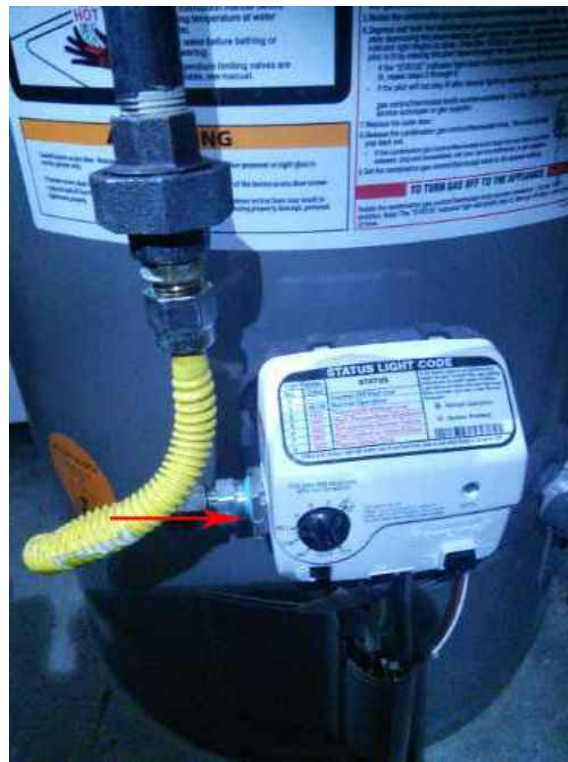
50 gallon natural gas water heater with a manufacture date of Feb. 2017.

There is no drop leg installed on the natural gas supply line for the water heater. This can lead to premature orifice plugging. Recomend further evaluation from a licensed plumber.

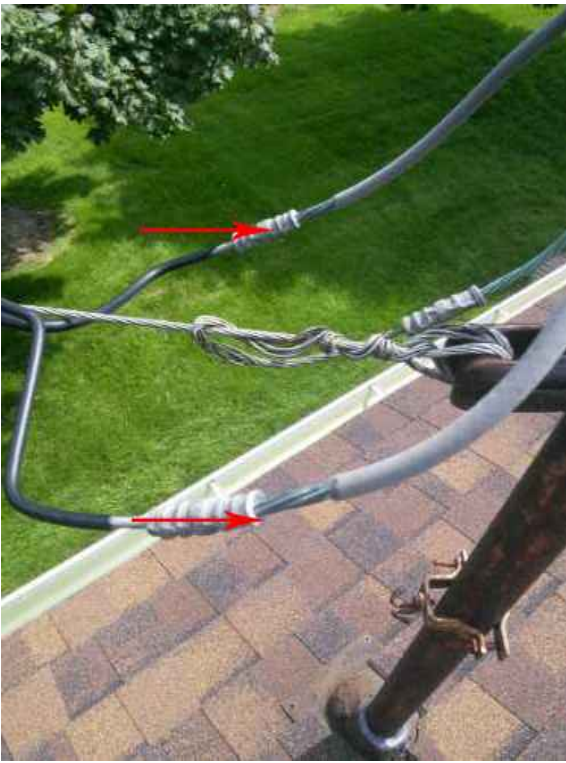
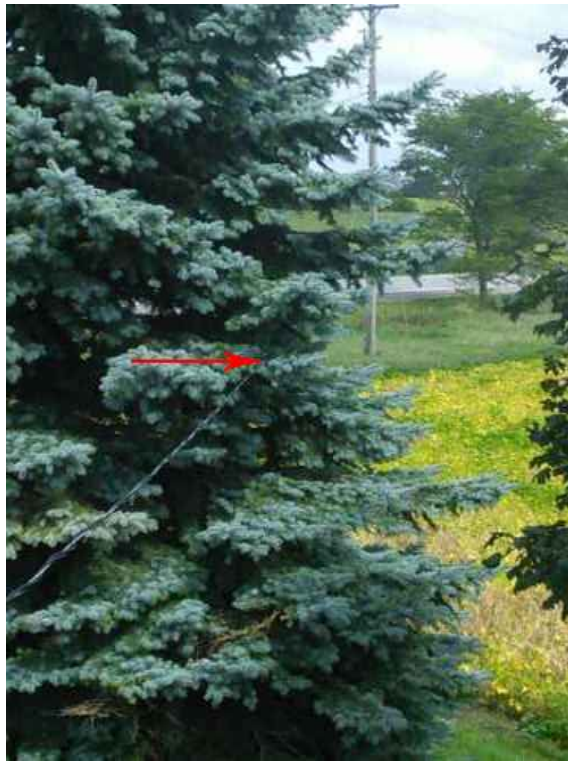
Service drop has exposed conductors at the electrical mast. Recommend further evaluation by a licensed electrician.

Service drop is also running through a pine tree on the east side of the house. Recommend further evaluation from the utility company.

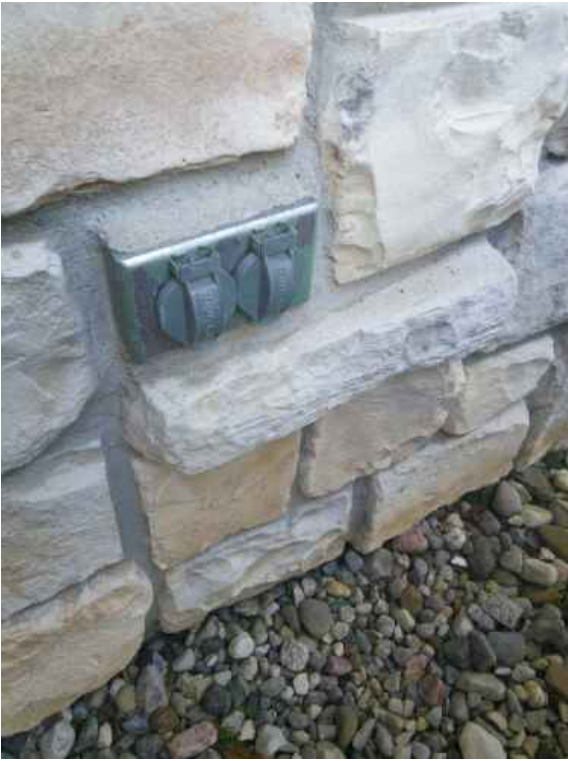
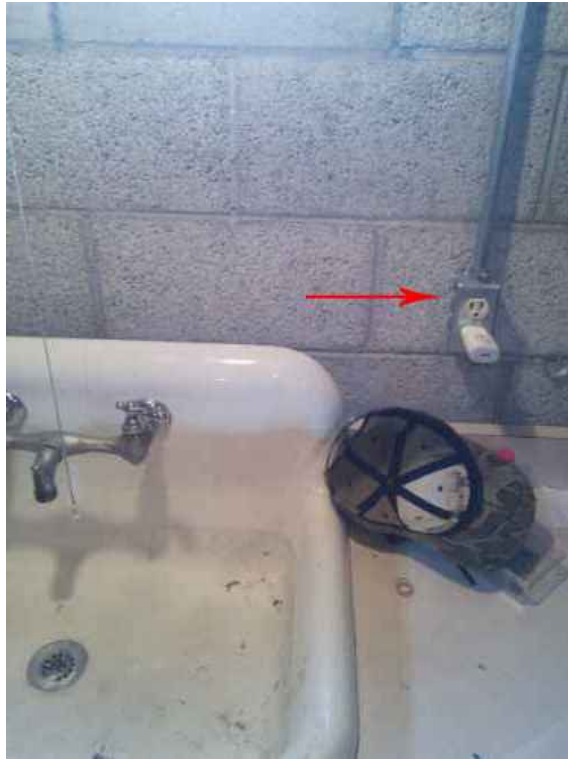
The electrical sockets near the sink in the basement are not GFCI. There are several outlets on the exterior of the house that are not GFCI. These are a potential shock hazard. Recommend further evaluation by a licensed electrician.

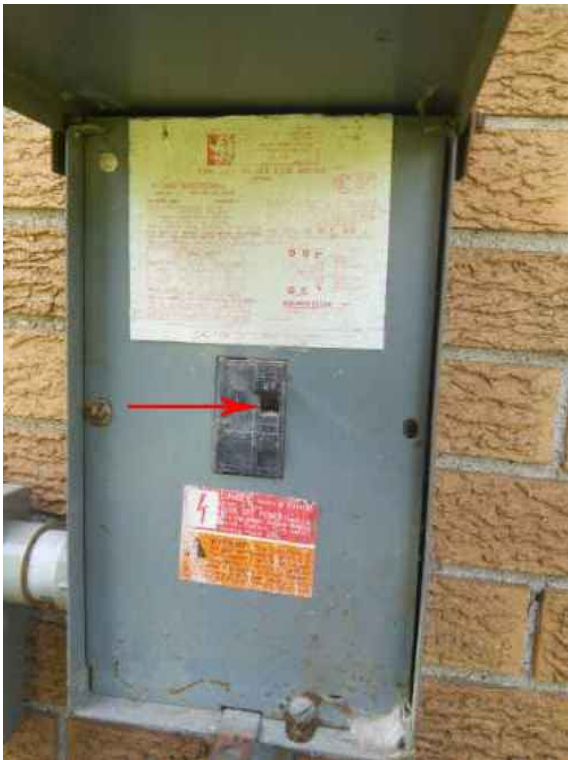
Main electrical shutoff is located on the east side of the exterior of the house.

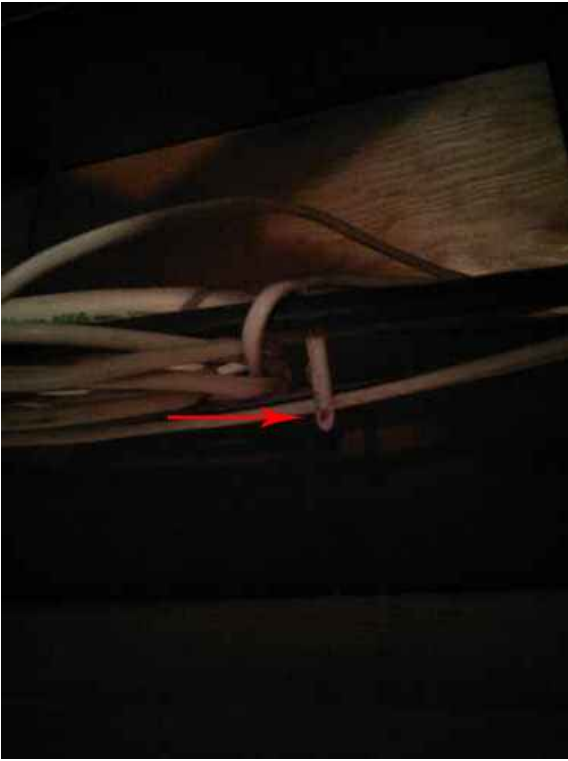
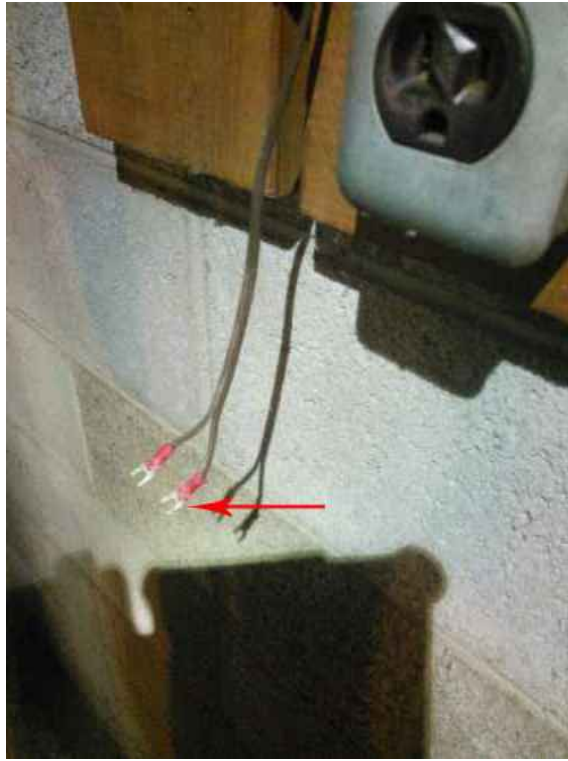
There are exposed non-terminated wires in the basement. These are believed to be from an old alarm system that is no longer in operation. Recommend further evaluation from a licensed electrician.

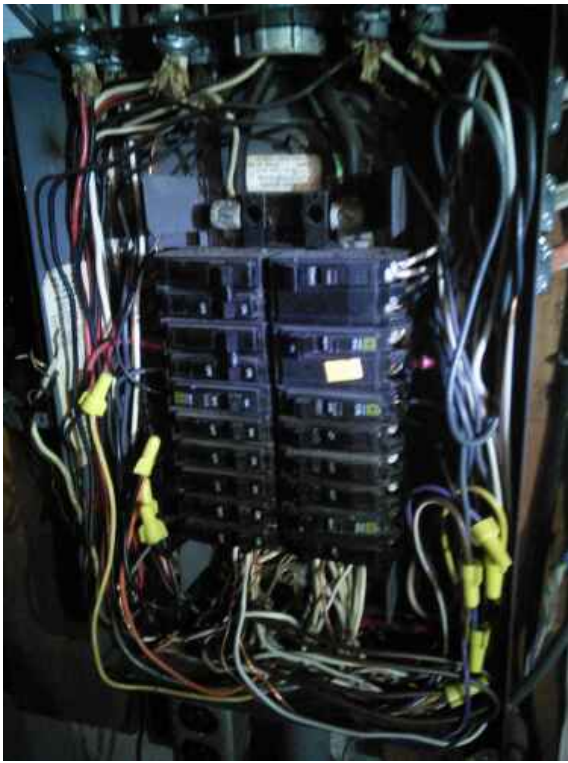
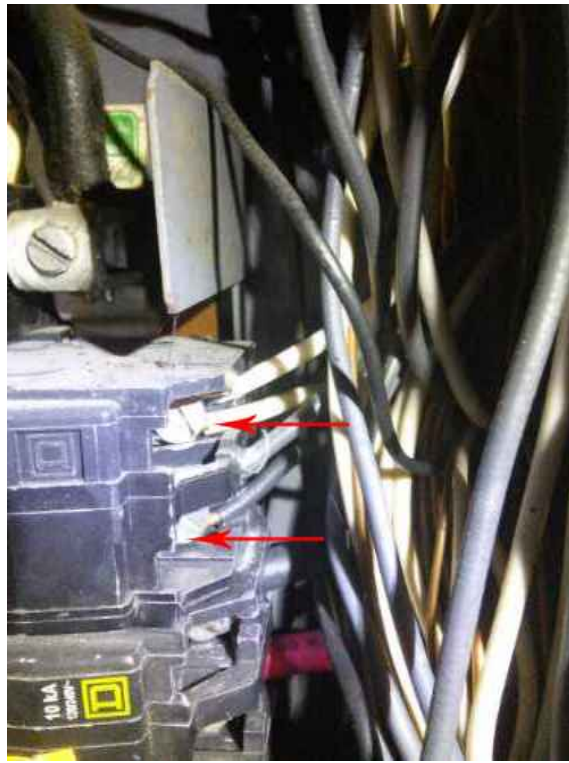
Poor

Electrical panel has double taps that are present. This is when two wires are terminated on the same breaker. The wires can eventually loosen and cause arcing. Recommend further evaluation from a licensed electrician.

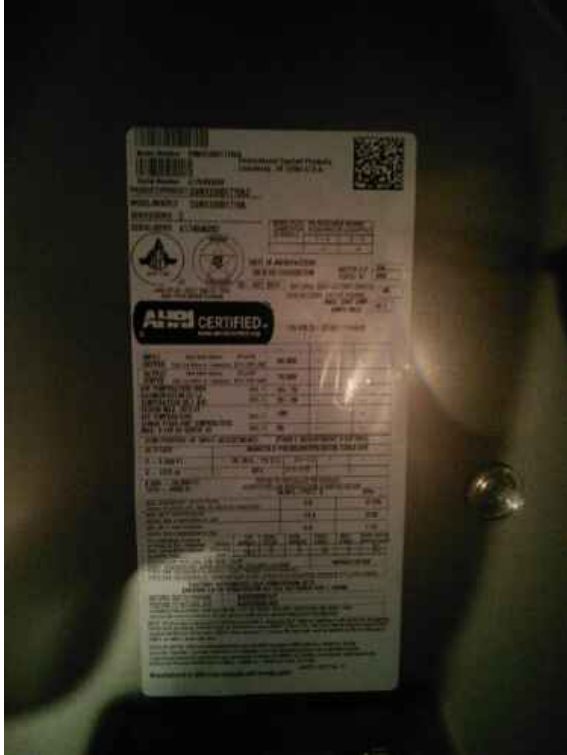
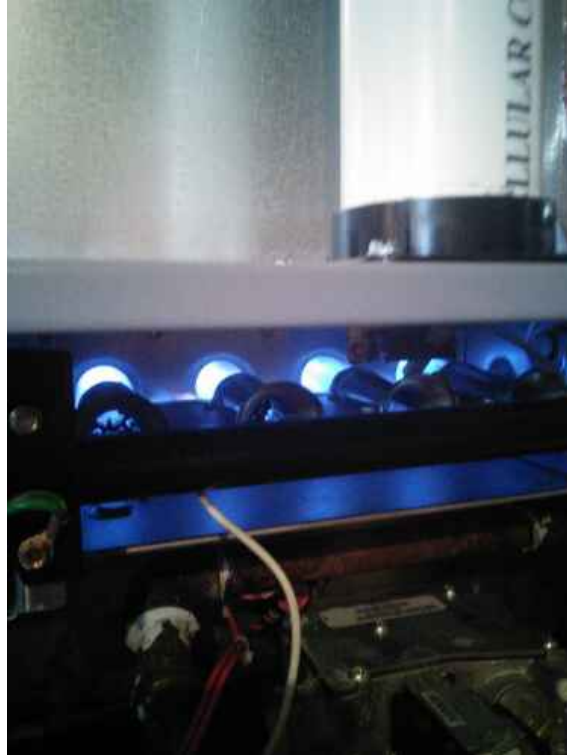
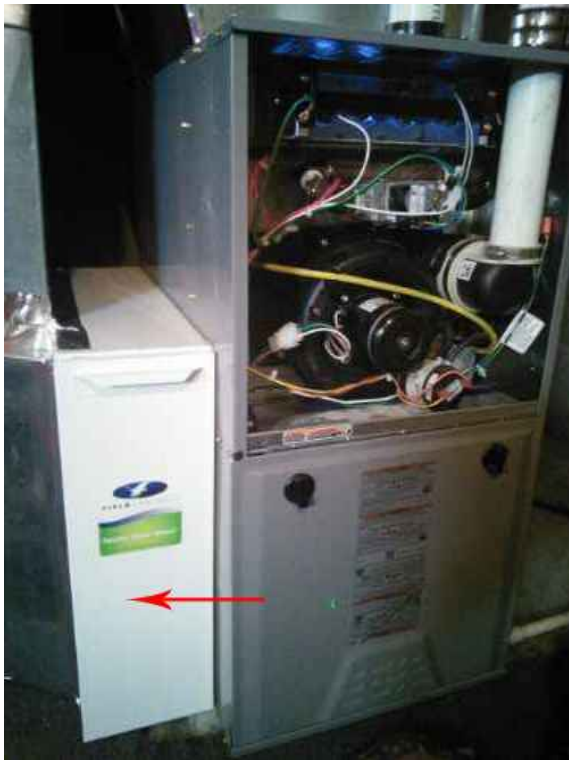
Comfort Maker brand natural gas furnace. Furnace fired with no issues and had a solid blue flame, indicating efficient burning of the fuel. Furnace filter is pictured below, recommend regular changing of the filter to maintain efficiency.

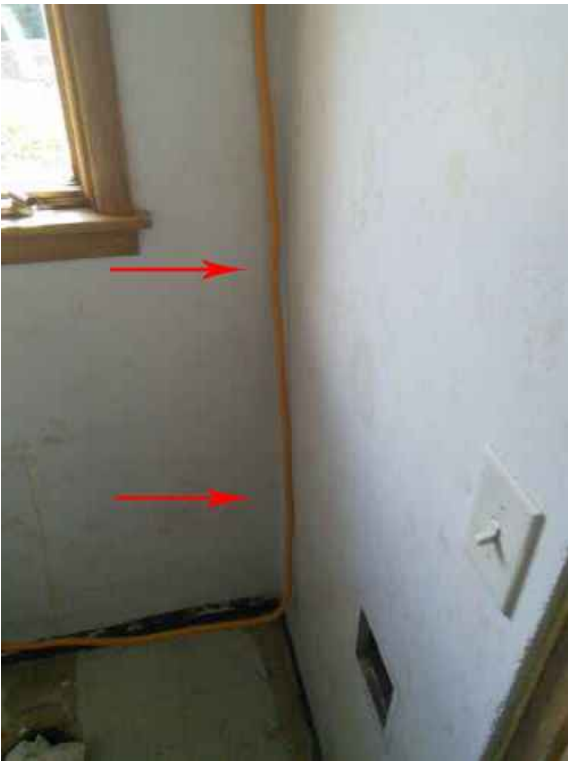
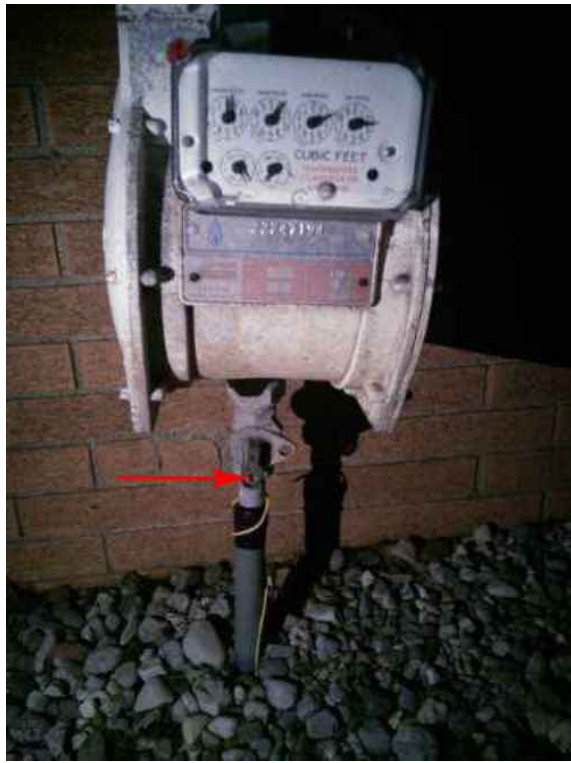
The natural gas line in the half bath located in the garage is not secured to the wall. This is a potential fire hazard. Recommend securing the Stainless Steel Corrugated Tubing (SSCT) to the wall.

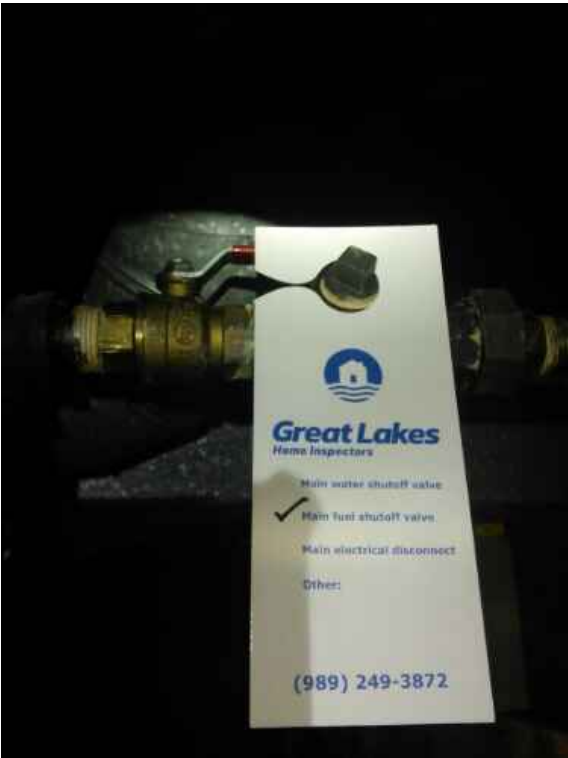
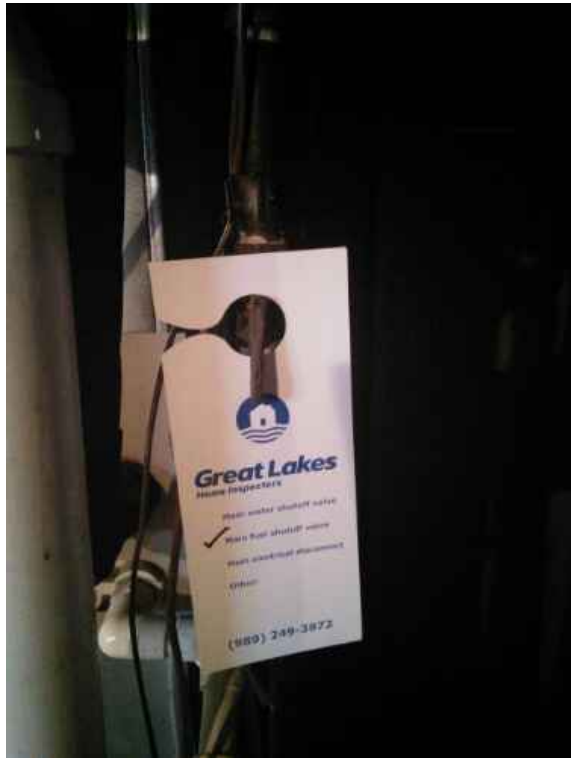
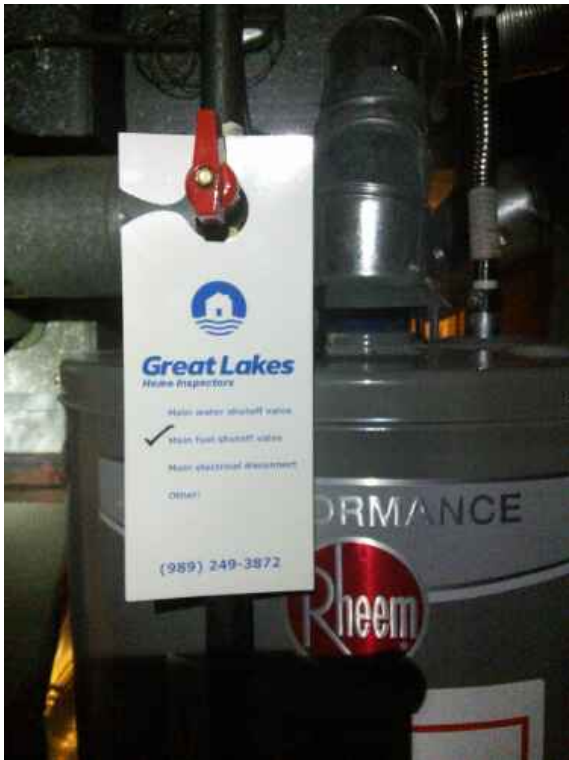
The main shut off valve for the natural gas is located below the meter on the north side of the house. The shut off valve for the auxillary generator and outbuilding is depicted in picture 3. The furnace natural gas shutoff is depicted in picture 4. The water heater natural gas shutoff is depicted in picture 5.

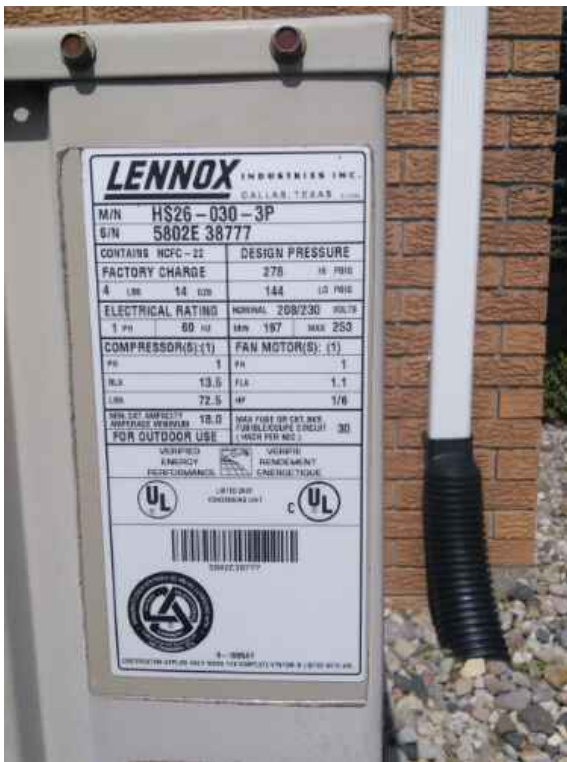
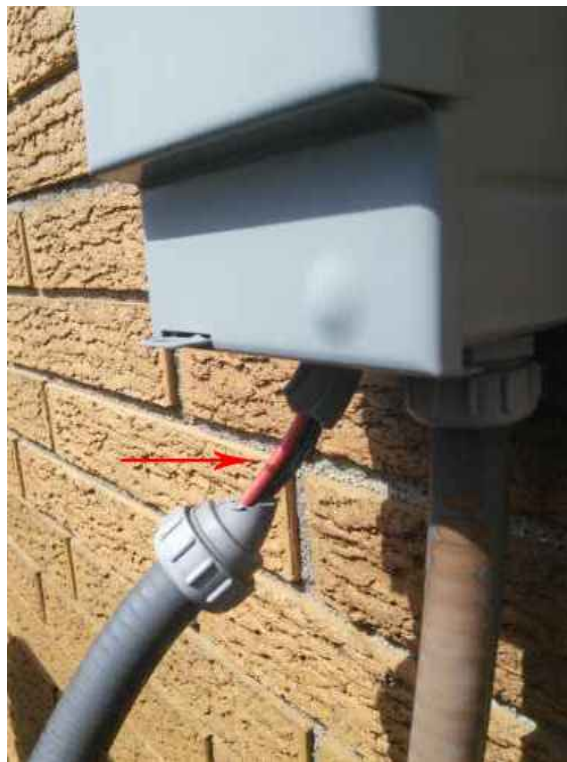
Lennox air conditioning system that was installed approximately 2002. This is at the expected lifespan of an air conditioner. Electrical conduit going to the unit was broken, recommend further evaluation from a licensed electrician.
