# Great Lakes Home Inspectors

**September 6th 2018, 1:45 pm**

**BUILDING ADDRESS:** 1234 Sample St  
**CITY:** Saginaw  
**STATE:** MI  
**ZIP CODE:** 48601  
**INSPECTION DESCRIPTION:** Ranch-style house with 2-car attached garage

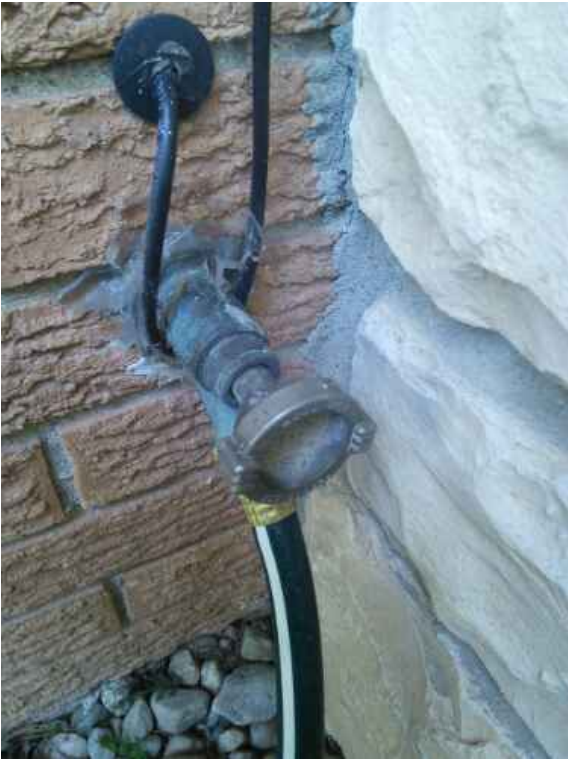
Both water spigots are not anti-frost spigots. These can potentially freeze during the winter and burst. Recommend further evaluation by a licensed plumber.
